## **Service Bulletin**

Bulletin No.: 22-NA-009

Subject: Information on New Torque Specification and Installation Procedure for ACDelco Spin-On Oil Filters

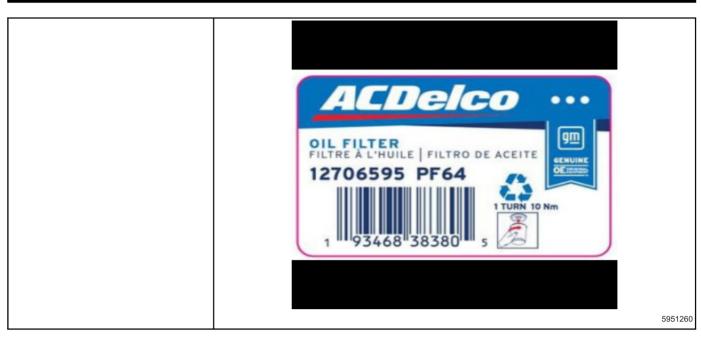
Information	<ol> <li>Install Oil Filter 1 full turn after gasket makes contact with the sealing surface on the filter mounting flange. If installing with a torque wrench, this should be approximately 10 N•mof torque.</li> </ol>
	This installation specification will be updated in Service Information (SI) and the label on the oil filters (example shown below) will be updated as well.
