Service Bulletin

Bulletin No.: 22-NA-010

Subject: Creaking Noise from Instrument Panel Area During Turns

Brand:	Model:	Model Year:		Build Date Breakpoint:		Engine:	Transmission:
		from	to	from	to		
Chevrolet	Blazer	2019	2020	December 1, 2019	December 1, 2020

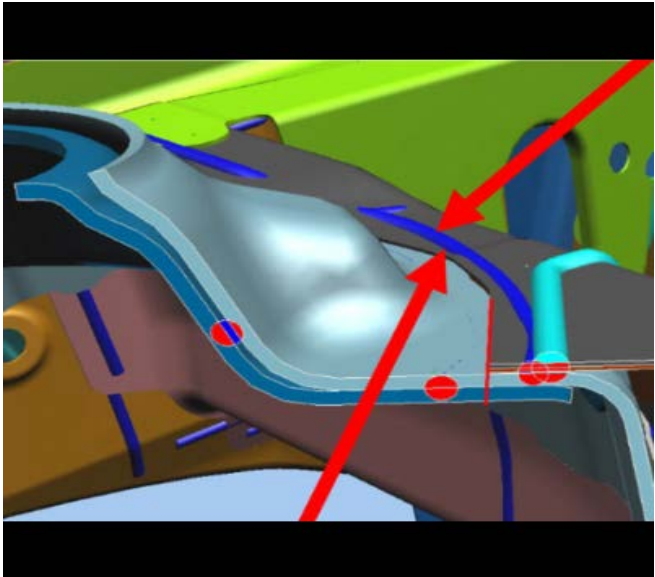
Involved Region or Country	North America Only
Condition	Some customers may comment on a creaking noise originating from the instrument panel area during turns.
Cause

<p style="text-align: right; font-size: small;">5962844</p> <p>The cause of the condition may be due to missing panel adhesive on top of right front suspension strut mount area not securing plenum cowl panel securely.</p>
Correction	<p>Diagnose with visual inspection and chassis ears.</p> <p>Add adhesive per instructions if adhesive is missing.</p>

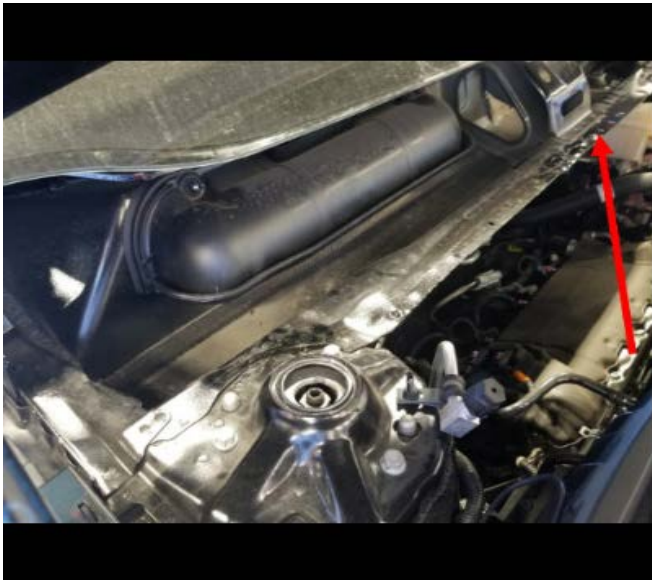
5962843

Attach Chassis Ears to the location shown above and move side to side along this flange to distinguish which side was the loudest.
