# Service Bulletin

Bulletin No.: 22-NA-013

**Subject:** Leaks in the Charge Air Cooler System. Malfunction Indicator Lamp (MIL) Illuminated - Multiple DTCs Set

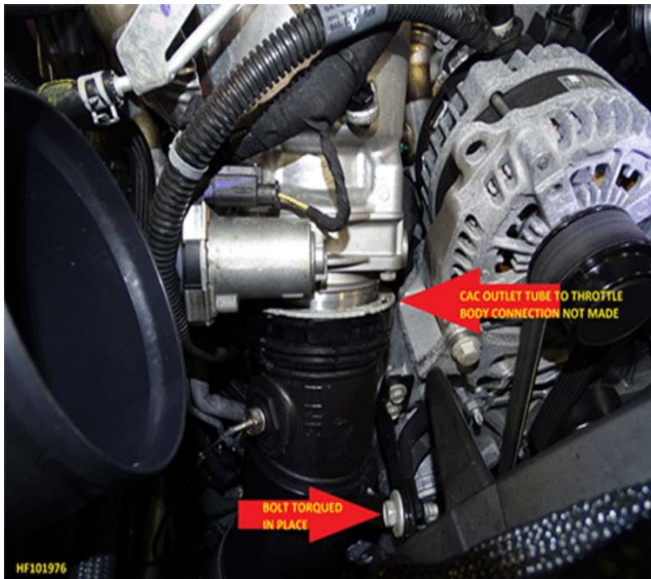
Check for non-secured connection of the charged air cooler pipe at the intake air flow valve (throttle body).  
Check for proper alignment of the charged air cooler pipe bracket and bolt hole.

If P2463 was not set and a charge air cooler leak or disconnect was found, after repairing charge air cooler connections, command Diesel Particulate Filter (DPF) Regeneration Enable with the scan tool before returning the vehicle to the customer.

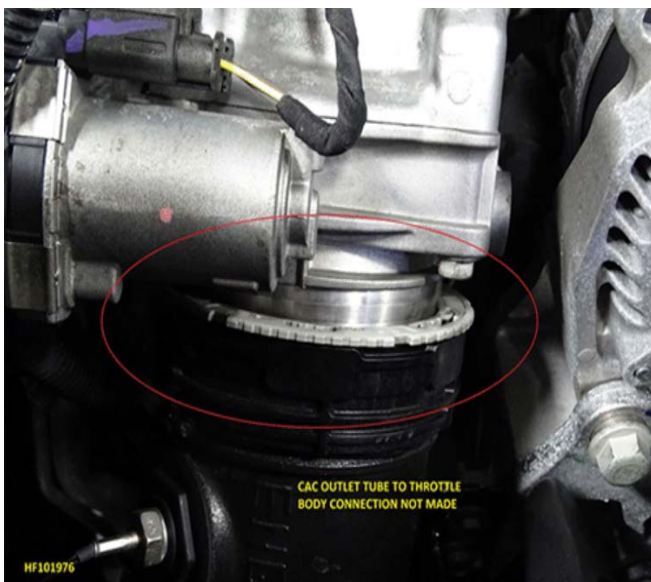
Non-secured connection.

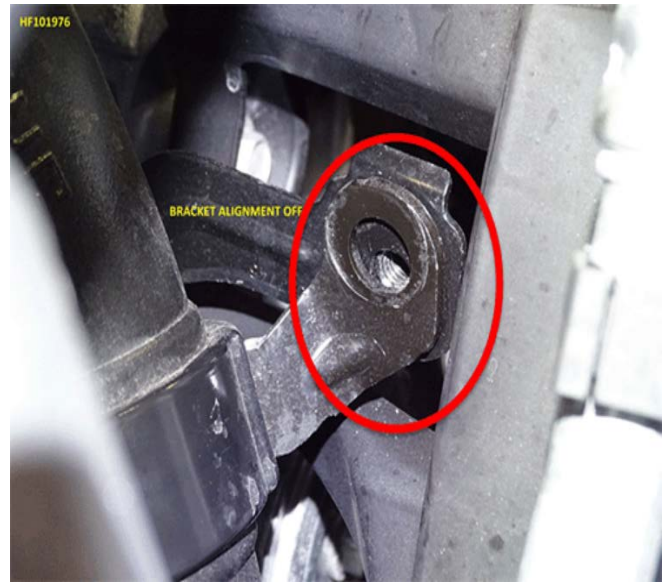
Mis-aligned charged air cooler pipe bracket and bolt hole after the charge air cooler outlet hose is connected properly to the throttle body.
