Service Bulletin

Bulletin No.: 22-NA-016

Subject: Transmission Control Module Offline Event

Brand:	Model:	Model Year:		Breakpoint Date:		Engine:	Transmission:
		from	to	from	to		
Chevrolet	Tahoe Suburban	2021	2021	SOP	August 24, 2020		
GMC	Yukon Yukon XL

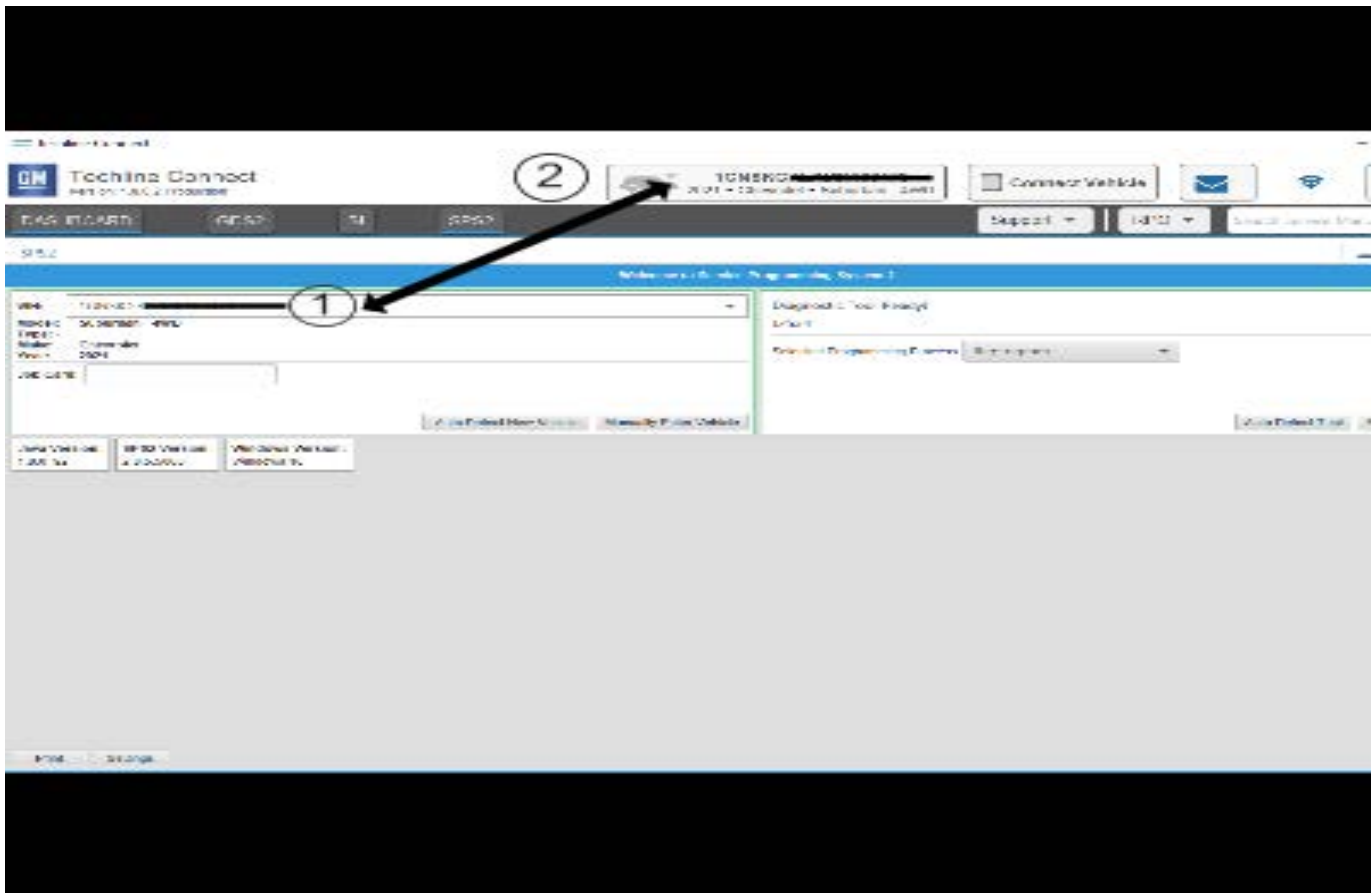
5743643

Caution: Be sure the VIN selected in the drop down menu (1) is the same as the vehicle connected (2) before beginning programming.

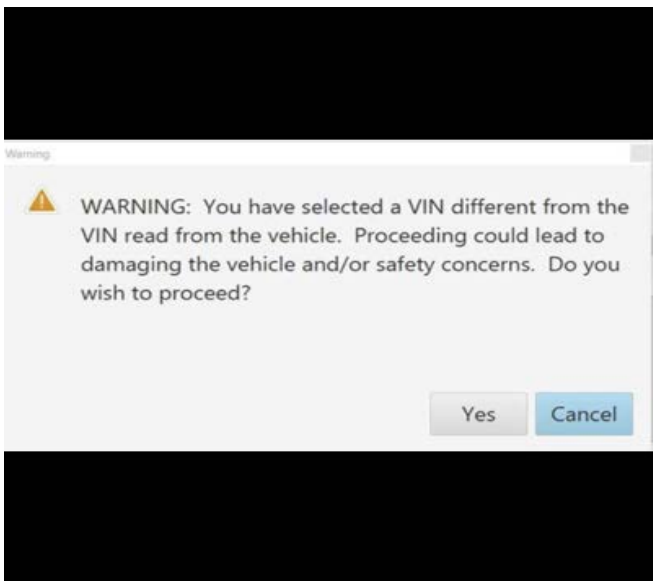
5877000

Important: If the vehicle VIN DOES NOT match, the message below will be shown
