# Service Bulletin

Bulletin No.: 22-NA-021

**Subject: Diagnostic Tip for Lack of Engine Performance - DTCs P003A, P0046, P0299 and/or P0234 Set**

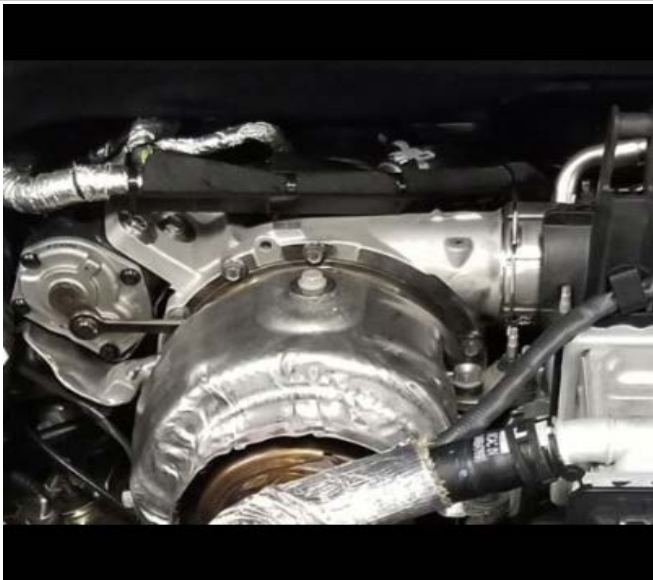
5655242

<b>Involved Region or Country</b>	North America, Russia, Middle East, Chile (West), Colombia (West), Ecuador (West), Paraguay (West), Peru (West), Japan, Cadillac Korea (South Korea), Thailand (ASEAN), Australia/New Zealand
<b>Condition</b>	Some customers may comment on a lack of engine performance. Some technicians may find one or more of the following DTCs set: <ul style="list-style-type: none"> <li>• P003A</li> <li>• P0046</li> <li>• P0299</li> <li>• P0234</li> </ul>
<b>Cause</b>	These conditions may be caused by loose bolts on the turbocharger actuator.

If any of the three actuators bolt are not fully seated, replace the turbocharger.  
If all the bolts are fully seated, this bulletin does not apply. Continue with normal Service Information diagnostics.
