Service Bulletin

Bulletin No.: 22-NA-026

Subject: Information on Brake Pulsation, Noise and/or Visible Pitting Condition to Brake Rotor Surface

Brand:	Model:	Model Year:		VIN:		Engine:	Transmission:
		from	to	from	to		
Chevrolet	Corvette	2021	2022	—	—	All	All

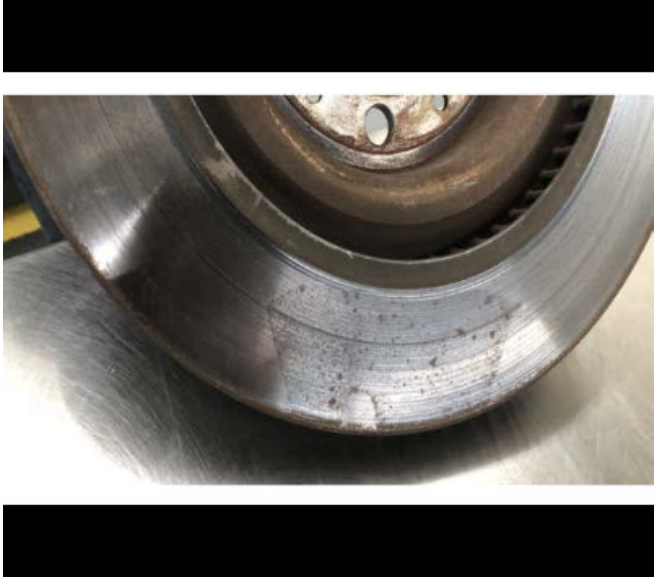
5969661

Involved Region or Country	North America, Europe, Middle East, Japan, Australia/New Zealand
Condition	<p>Note: This condition may more commonly appear after the vehicle sits for an extended period of time, especially in high humidity.</p> <p>Some customers may comment on feeling a brake pulsation or hearing a noise when applying the brakes. They may also comment on seeing a pitting condition with the brake rotor's surface.</p> <p>This condition is called out in the Owner Manual. Refer to <i>Brakes</i> and should be reviewed with the customer.</p> <p><u>Following the information below will be helpful with reducing the surface corrosion.</u></p>
Cause

<p style="text-align: right;">5969664</p> <p>The cause of this condition may be corrosion pad spotting and surface grooving on the brake rotor surface.</p>
<p>Correction</p>	<p>To help restore optimal braking performance and reduce noise, complete the Procedure noted below.</p>

1. . Using the G-Force Gauge in the HUD display, apply the brakes 10 times starting at 100 km/h (60 mph) to 50 km/h (30 mph) while decelerating at 0.4g. In the Owner Manual, refer to *Head-Up Display (HUD)*. This a medium brake application. Drive for at least 0.5 km (0.3 mi) between applying the brakes.
2. If further cleanup of the brake discs is needed, repeat this procedure with 0.7g applications.
