## MAS002969 - Blow-by pressure sensor faults

DATE: February 17, 2022

**MODELS:** M156, M157, M161

**ENGINE TYPES:** F160 (V6), F154 (V8)

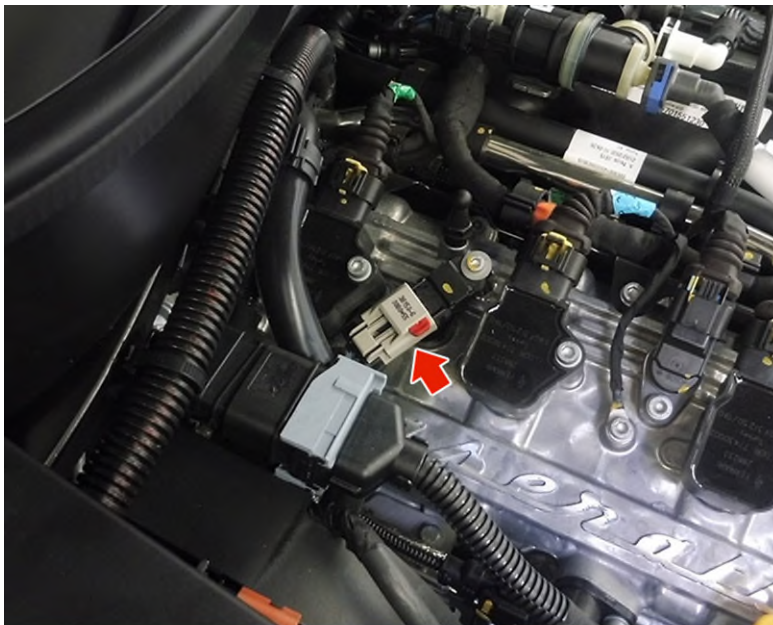
Picture 1 – The blow-by pressure sensor is located on bank 1 on F160 (V6) engines

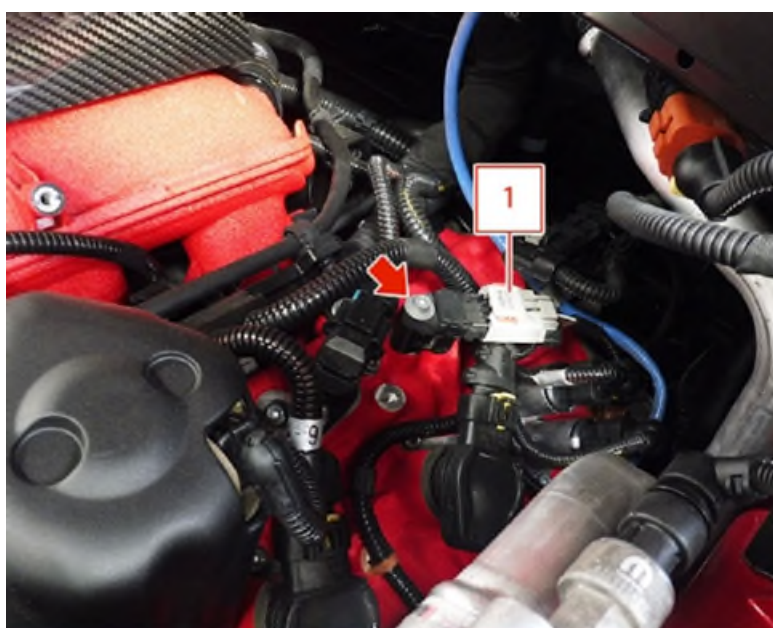
Picture 2 - The blow-by pressure sensor is located on bank 2 on F154 (V8) engines

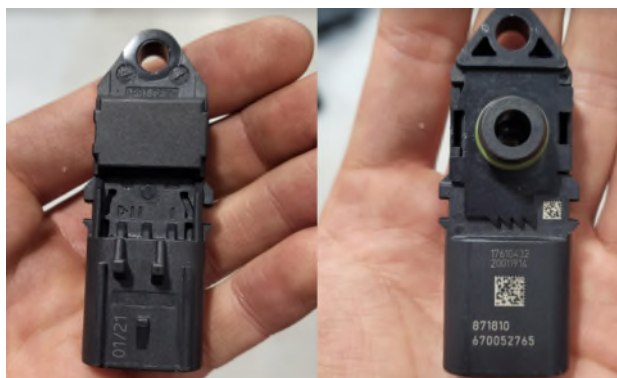
Picture 3 – Blow-by pressure sensor (F160)

- 6) Disconnect the 12V battery and both connectors of blow-by pressure sensor and ECM. Referring to Modis wiring diagram FE0802, check the continuity of the harness between the blow-by pressure sensor and the ECM. Verify the insulation of each wire (either to chassis ground and to each other). Check the intermediate connection of the signal line (D021) for any loose or corroded pins. Check the pins on blow by pressure sensor and ECM for any bent/corroded pins.
- 7) Connect the blow-by pressure sensor and ECM connectors. Connect the 12V battery. With ignition on, measure the voltage between pin 1 and pin 2 of the blow-by pressure sensor connector (it should be 5V).
- 8) If there are no issues found with the above checks, remove the blow-by pressure sensor and take two pictures of both the front and rear sides of the sensors (see Picture 3 below).

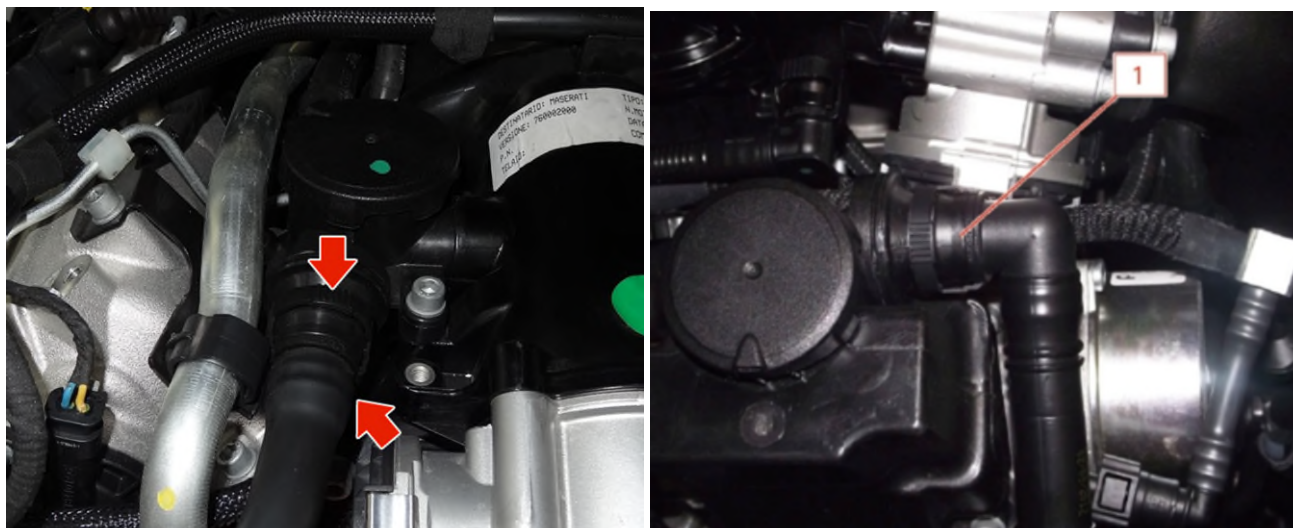
Picture 4 (left) and Picture 5 (right) – V6 and V8 blow-by valve location

- 9) Disconnect the pipe between the blow-by valve and the RH turbocharger at the area's highlighted in Pictures 4 (V6) and 5 (V8) below. Take pictures of the blow-by valve (see example shown in Picture 6 as comparison).

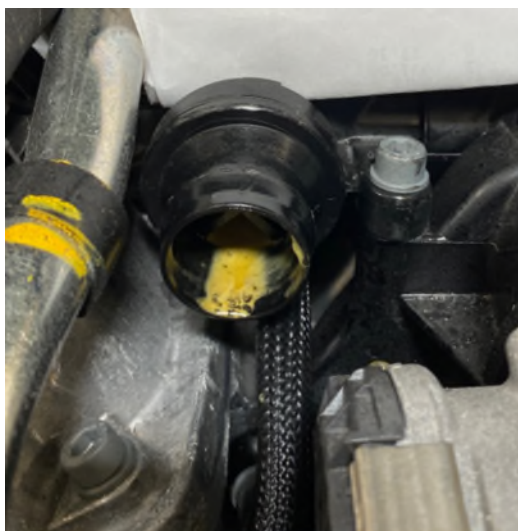
Picture 6 – Blow-by valve contamination check
