Technical Journal

Cannot lock/unlock vehicle with remote control key

REF NO: TJ 36195.1.0	ISSUING DEPARTMENT: Technical Service	CAR MARKET: United States and Canada	
PARTNER: 3 US 7510 Volvo Car USA		ISSUE DATE: 2022-03-28	STATUS DATE: 2022-04-29
FUNC GROUP: 3666	FUNC DESC: Access (central looking & remote)	Page 1 of 5

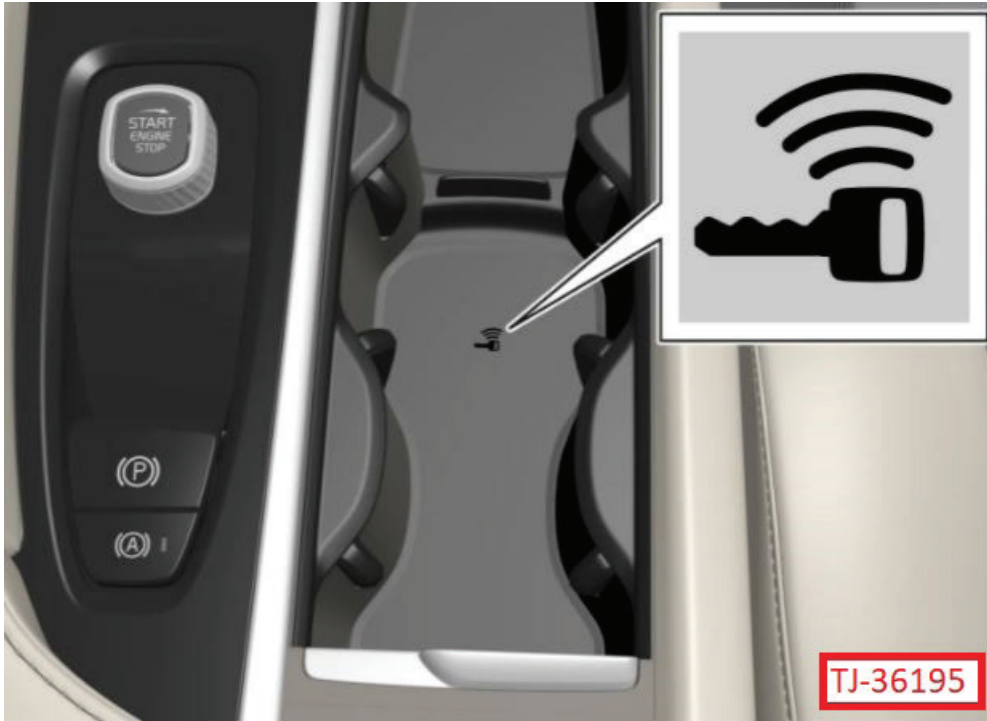
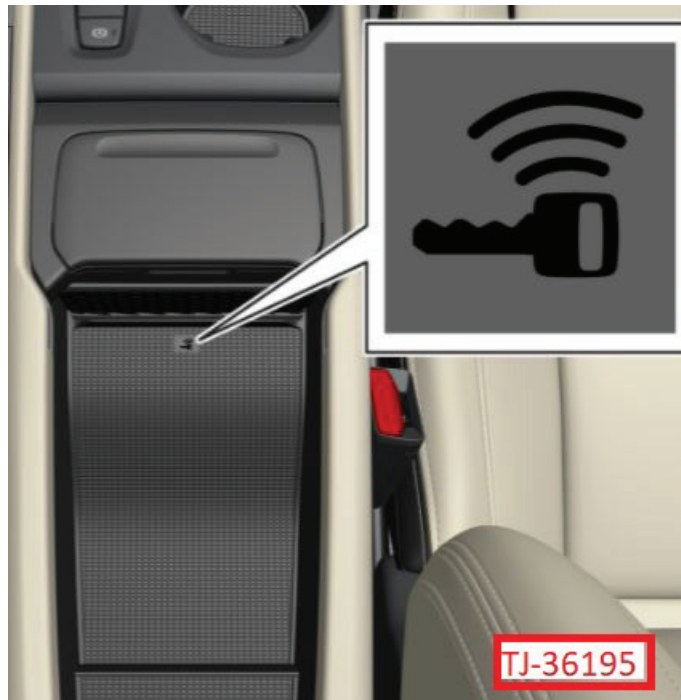
1. Cannot Lock/unlock vehicle with the “RCK”, but vehicle can be unlocked with the mechanical key blade located inside the “RCK” (see attachment “**Mechanical location**”).
2. If symptom nr “1” has been confirmed and starting the vehicle with the “RCK” in the backup position and DIM message stating “Key not found”. (See picture for backup position location)
3. The vehicle can be started with the “RCK” in the backup position located in the tunnel console, while having DIM message “SOS E-call service required”.(see attachments “Backup position”)
4. No communication when attempting to connect/readout vehicle with VIDA.

Volvo Cars are aware of the symptoms described in this TJ. No time plan for a solution is yet available. If any of the symptoms described under “Description” is present please make the TCAM powerless by removing TCAM fuse + the BuB connector.
