SIB 11 05 21

SERVICE ACTION: REPLACE THE MECHANICAL COOLANT PUMP

This Service Information Bulletin (Revision 3) replaces SI B11 05 21 dated April 2022.

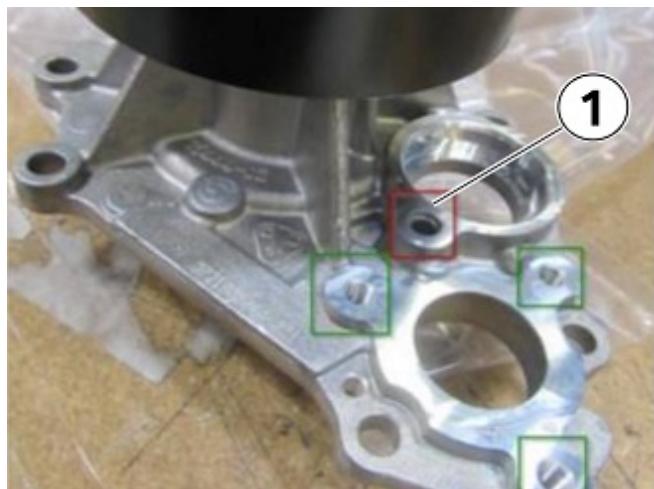
**NOTE:** The bolt hole for the coolant flange (1) may not be threaded. The self-tapping screw from the original water pump must be re-used.

Follow this tightening sequence (threads or no threads present)

1. Tighten to 12.5 Nm
2. Loosen the screw 360 degrees (one full turn)
3. Tighten the screw again to 12.5 Nm
