## SIB 64 05 21

## RATTLING NOISE PERCEPTIBLE IN VEHICLE INTERIOR WITH AC ACTIVATED

This Service Information Bulletin (Revision 1) replaces SI B64 05 21 **dated June 2021**.

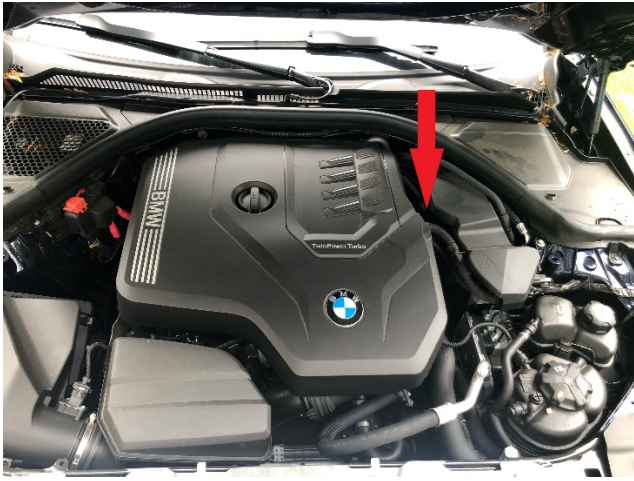
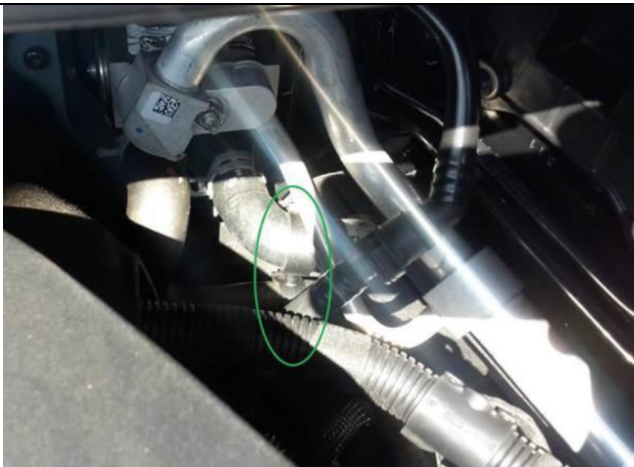
The refrigerant line double pipe and a clamp on the return line of the internal heat exchanger are in line with each other (in the direction of travel, on the left (driver) side of the engine compartment below/behind the DME).and are making contact.

The hoses are contacting here (arrow).
--	--
