TECHNICAL SERVICE BULLETIN

Technical Service Bulletin: 79-1514

Forest River is alerting you to an issue involving certain 2021 XLR Boost XLT27QBX Toy Hauler recreational vehicles. Please see the information below which describes the issue and provides you with details on the steps you should take to have your vehicle repaired.

TECHNICAL SERVICE BULLETIN 79-1514 REMEDY INSTRUCTIONS

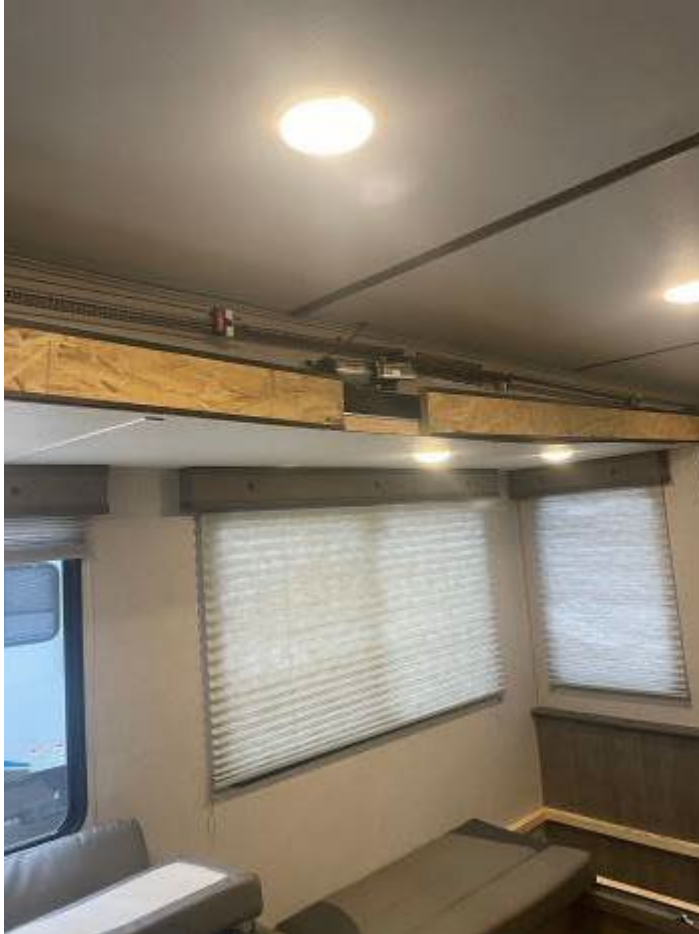
Concern:
The slideroom roof header is split into two pieces whereas it should be a single solid piece across the entire length of the slideroom roof.

CURRENT HEADER INSTALLED

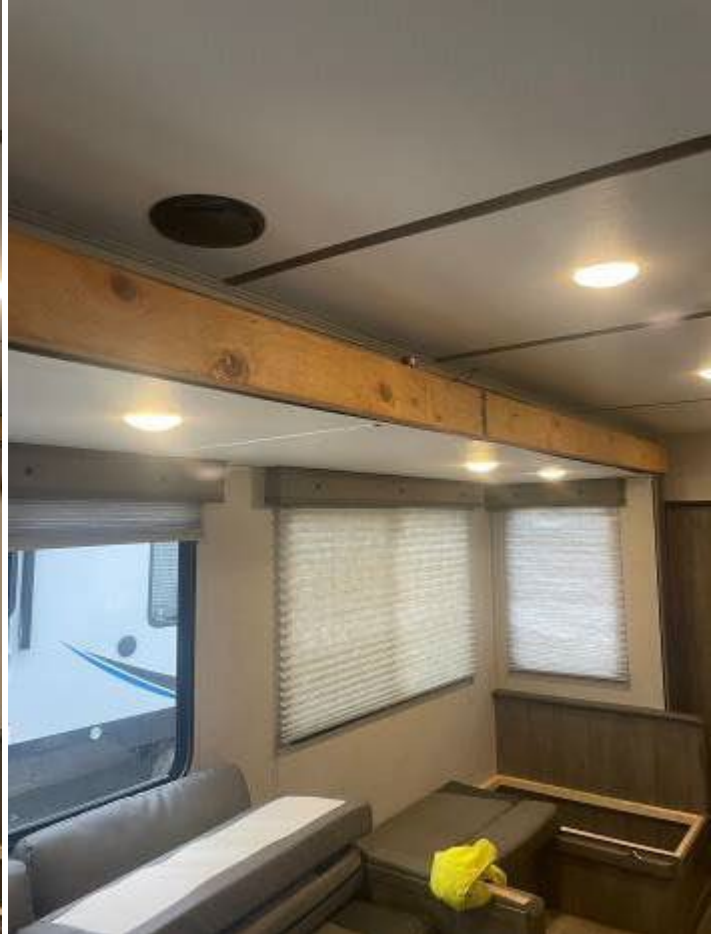
HEADER AFTER REMEDY

STEP 8: INSTALL THE 2" X 6" FLUSH TO ONE END OF THE SLIDEROOM HEADER BUT 1/4" UP FROM THE BOTTOM OF THE SLIDEROOM HEADER. USE A MINIMUM OF A 3" SCREW TO SECURE THE 2" X 6" TO THE SLIDEROOM ROOF;

STEP 9: AT THE OPPOSITE END, SECURE THE 2" X 6" FLUSH TO THE OTHER END OF THE SLIDEROOM HEADER USING THE SAME SCREW(S).

STEP 10: BEGIN IN THE MIDDLE AND SECURE THE 2" X 6" OUTWARDS EVENLY UNTIL COMPLETE;

STEP 11: REINSTALL SLIDEROOM FASCIA TO THE 2" X 6" AND TRIM AS NEEDED. INSTALL 1 1/2" WIDE CEILING PANEL TO THE BOTTOM OF THE NEW HEADER;
