# Service Bulletin

Bulletin No.: 20-NA-079

**Subject: Front Brake Squeal Noise Heard During Light Brake Pedal Application**

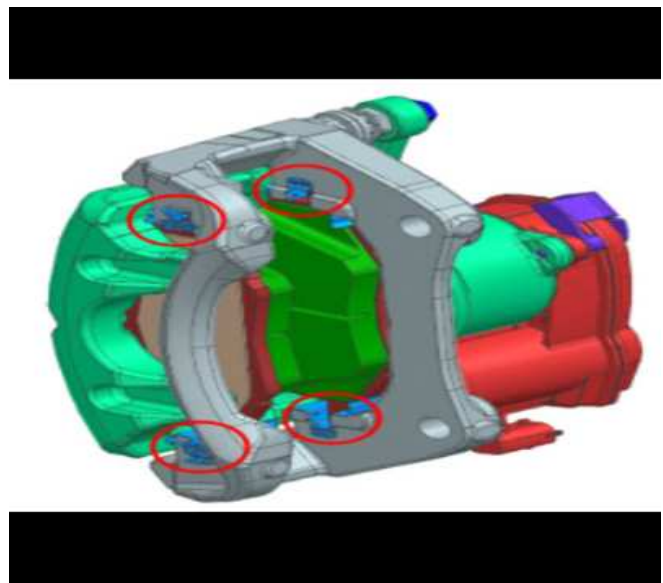
6077243

**Note:** There are 4 Pad abutments per caliper.

3. Apply Molykote M-77 Grease (GM P/N 19356408) on caliper pad spring abutment and clip as shown in the graphic above.
4. Install new front brake disc pads and sensors (if equipped). Refer to *Front Disc Brake Pads Replacement* in the Service Manual.
5. Verify brake noise has been eliminated.

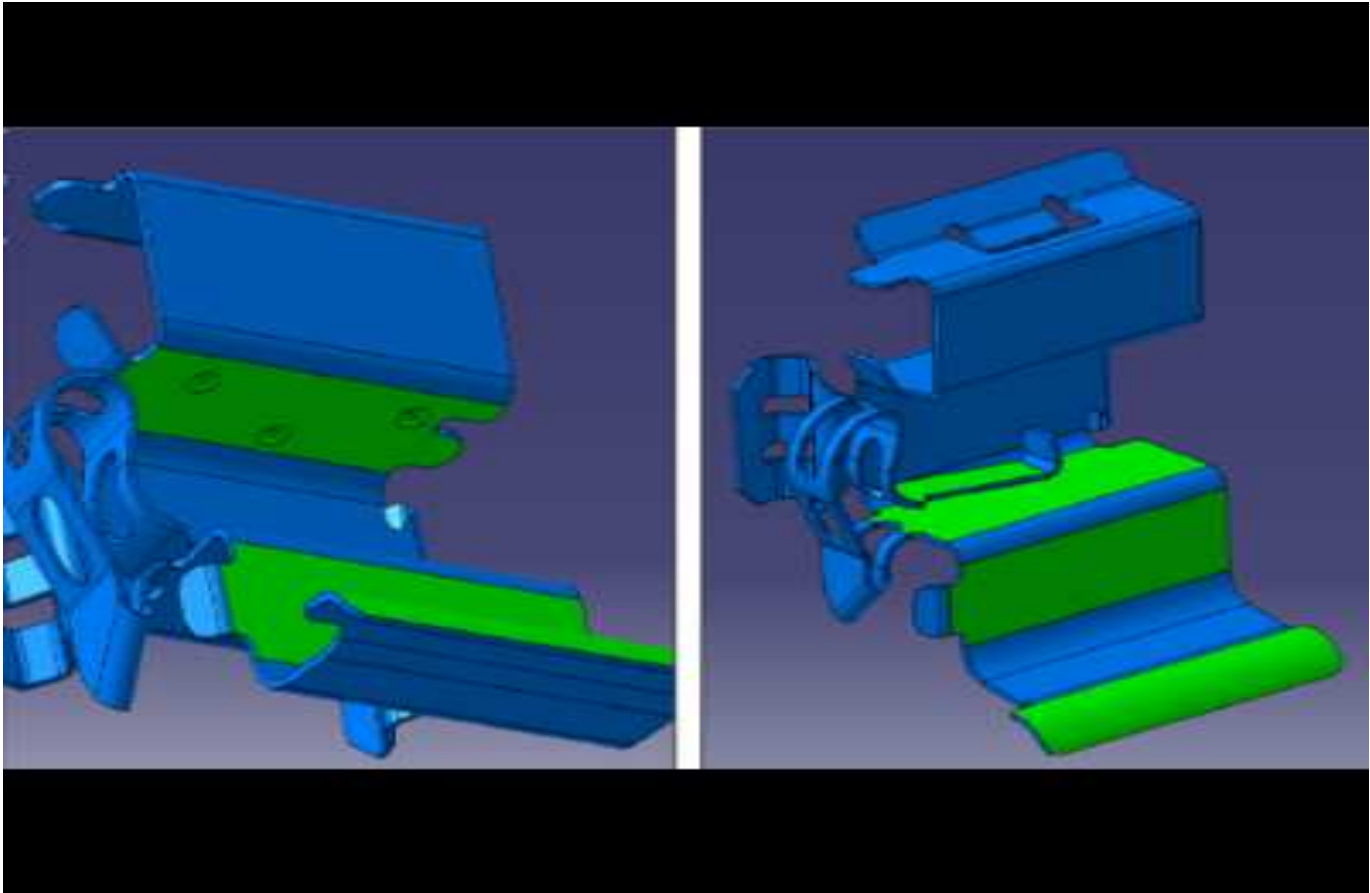
6077247

**Note:** The green area shown above designates the required grease positions.

**Note:** The recommended grease volume is about 1.1 g per caliper.

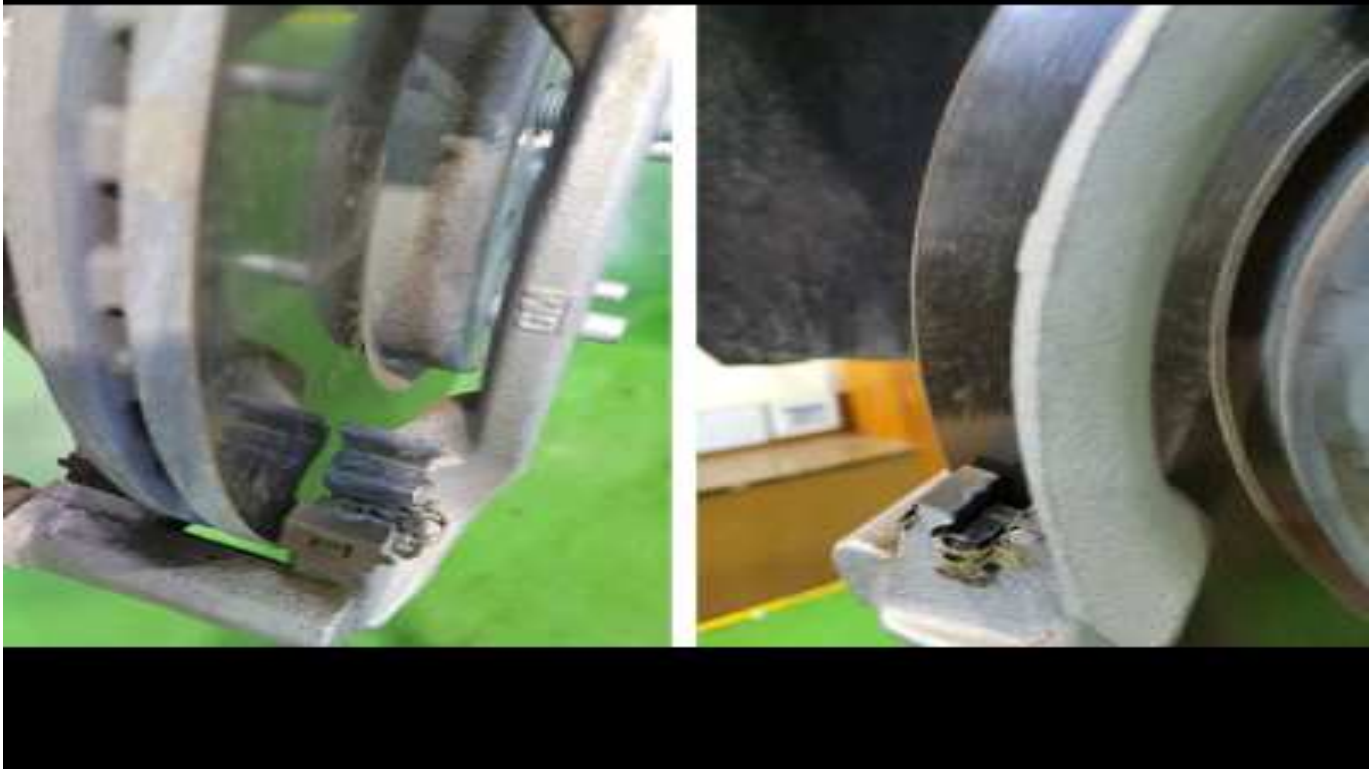
6077250

**Note:** The above graphics are actual grease adding examples.
