# Service Bulletin

Bulletin No.: 20-NA-175

**Subject: Vertical Misalignment Between Cab and Pickup Box on Driver Side of Vehicle**

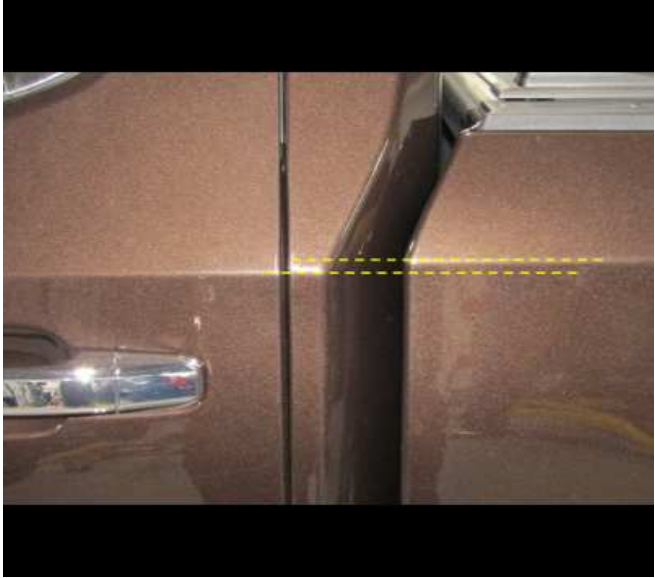
<p style="text-align: right;">5645798</p> <p>Some customers may comment on noticing anywhere from 2 –10 mm (0.08 – 0.4 in.) vertical misalignment of the body feature line between the cab and the pickup box, on the driver's side of vehicle.</p>
<p><b>Cause</b></p>	<p>The cause of the condition may be pickup box structure variation.</p>
<p><b>Correction</b></p>	<p>Realign the left side of the cab and install shim washers, following the steps in the Service Procedure below.</p>
