# Service Bulletin

Bulletin No.: 22-NA-057

**Subject: Fuel Door Does Not Open, Fuel Door Tappet Falls Out of the Hinge**

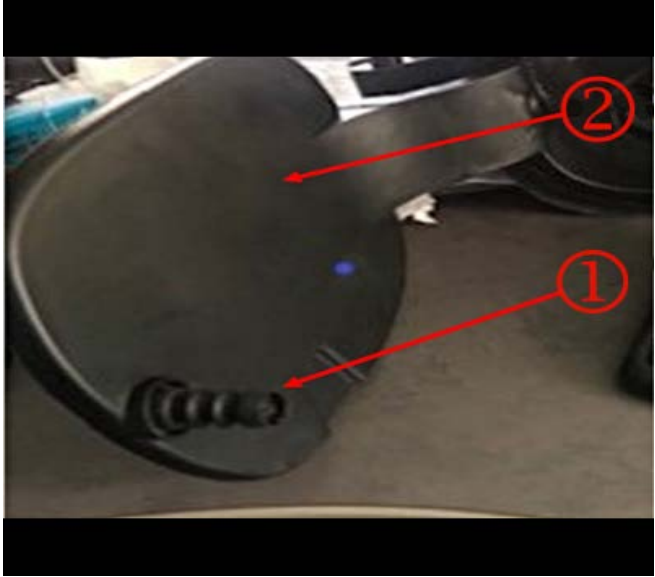
<p style="text-align: right;">6003725</p>

<b>Involved Region or Country</b>	North America
<b>Condition</b>	<p>Some customers may comment on having one of the following conditions:</p> <ul style="list-style-type: none"> <li>• Fuel door does not open</li> <li>• Fuel door tappet falls out of the hinge</li> </ul>

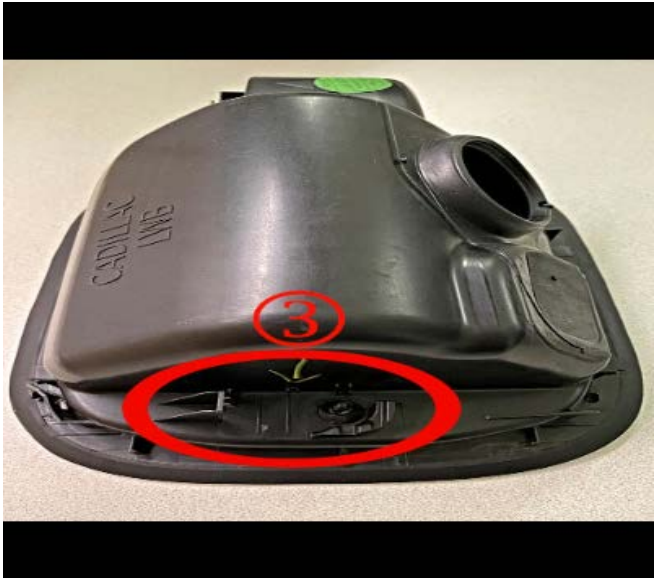
<p style="text-align: right;">6014256</p> <p>This condition may be caused by the tappet, as shown in the picture above (tappet and rubber boot) (1), becomes detached making the tappet loose in the housing hinge (2) misaligning the tappet to the lock actuator or the tappet is no longer retained to the hinge (missing tappet). The misalignment of the tappet to the lock actuator could cause the fuel door to not operate correctly and in some cases damage the lock actuator or lock actuator mount (3), shown in the picture above. A missing tappet boot may also cause the tappet to become detached to the hinge as the boot is part of the secure attachment of the tappet to the hinge.</p>
<p><b>Correction</b></p>	<p>If the tappet or boot is missing, replace the tappet following the procedure below.  <b>Note:</b> Replace the fuel door if it is damaged, new fuel door comes with the tappet.</p>

1. Remove the tappet, turn clockwise  $\frac{1}{4}$  turn and discard.
2. Align the new tappet base tabs to the hinge opening and turn counter clockwise  $\frac{1}{4}$  turn, making sure the tappet boot is correctly positioned and

**Note:** The new tappet should NOT have any movement in any direction.
