Service Bulletin

Bulletin No.: 22-NA-095

Subject: Front Brake Squeal Noise Heard During Light Brake Pedal Application

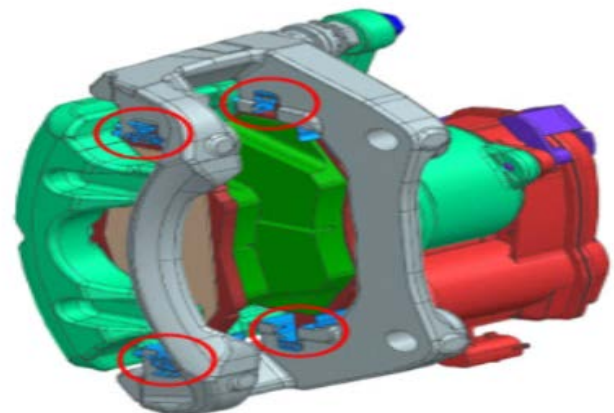
6077243

Note: There are 4 Pad abutments per caliper.

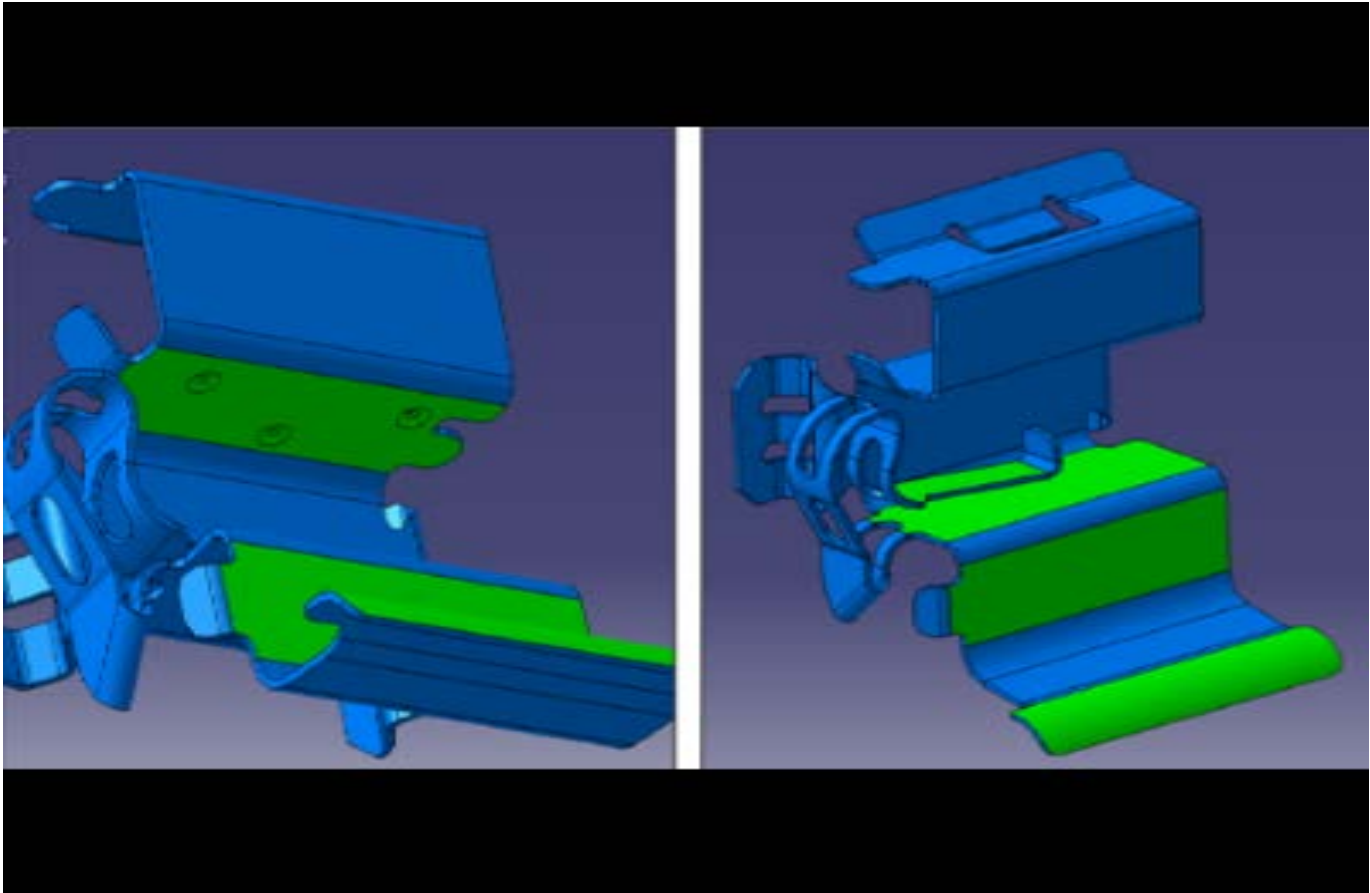
6077247

Note: The green area shown above designates the required grease positions.

3. Apply Molykote M-77 Grease (GM P/N 19356408) on caliper pad spring abutment and clip as shown in the graphic above.
4. Then reinstall the existing pads. Refer to *Front Disc Brake Pads Replacement* in the Service Manual.
5. Verify brake noise has been eliminated.

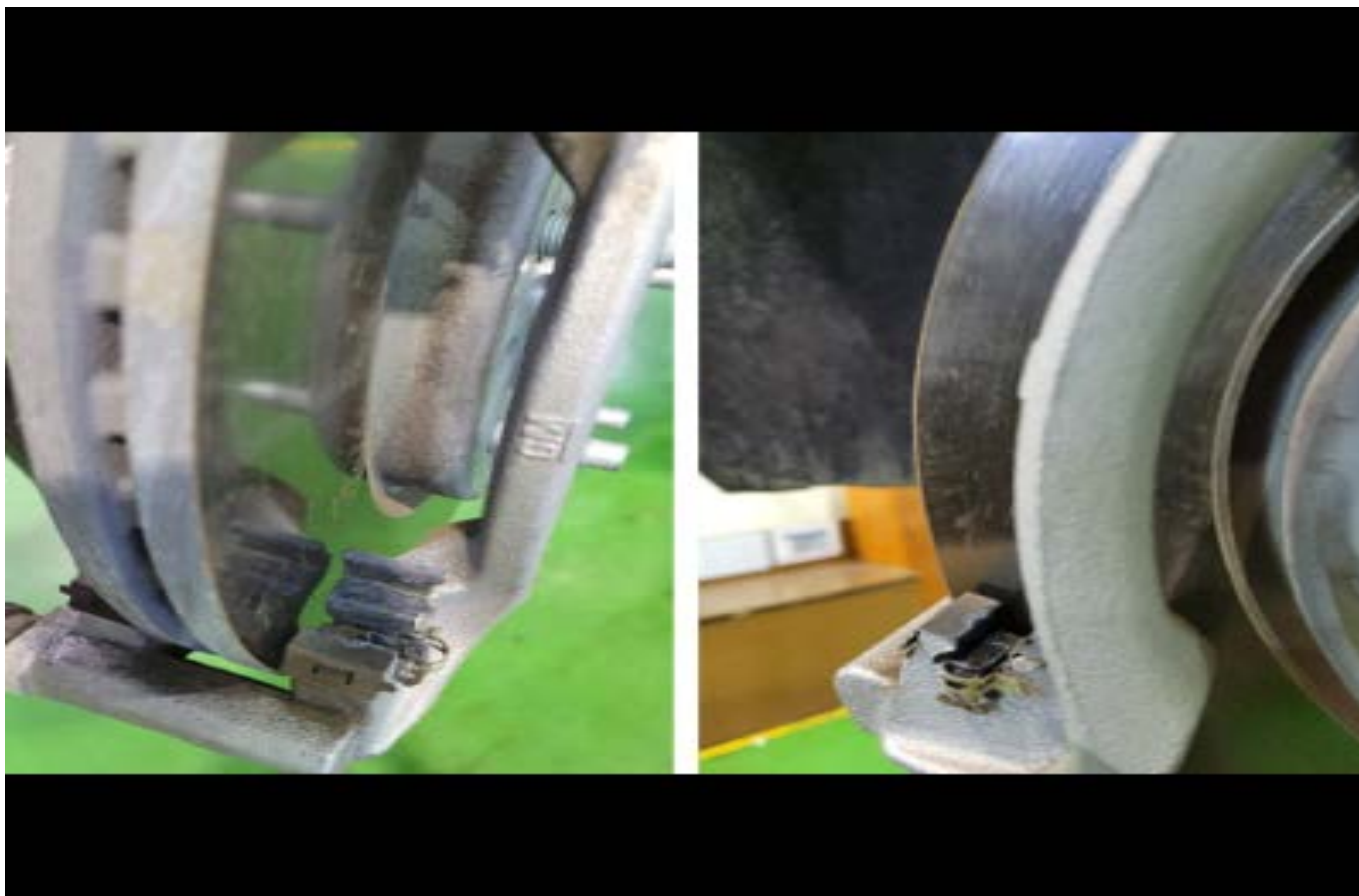
6077250

Note: The above graphics are actual grease adding examples.

Note: The recommended grease volume is about 1.1 g per caliper.
