TECHNICAL SERVICE BULLETIN

Technical Service Bulletin: 79-1514

Forest River is alerting you to an issue involving certain 2019 – 2022 – XLR Boost XLT27QBX Toy Hauler recreational vehicles. Please see the information below which describes the issue and provides you with details on the steps you should take to have your vehicle repaired.

TECHNICAL SERVICE BULLETIN 79-1514 REMEDY INSTRUCTIONS

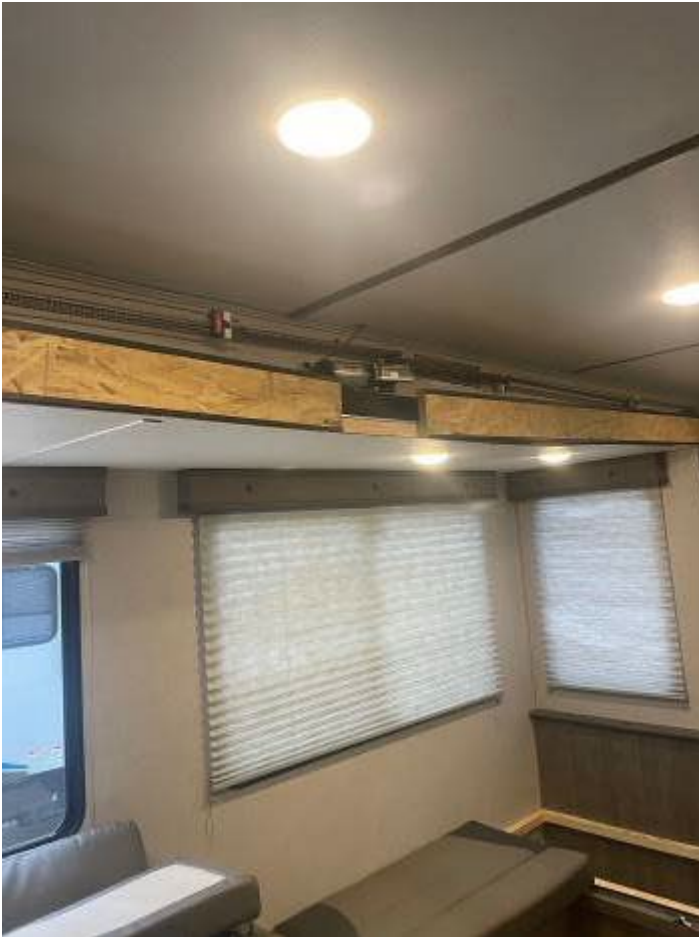
FIGURE 1

The slideroom roof header is split into two pieces whereas it should be a single solid piece across the entire length of the slideroom roof. This may allow water to intrude into the vehicle.

- USE A FLASH LIGHT TO LOOK BEHIND THE FASCIA ALONG THE ROOF;
- IF THERE IS **NOT** A GAP AS DEPICTED IN **FIGURE 2** CLAIM ONLY THE INSPECTION TIME;
- IF THERE **IS** A GAP IN THE BOARDS BEHIND THE FASCIA AS DEPICTED IN **FIGURE 1** MOVE TO REMEDY;
