Service Bulletin

Bulletin No.: 22-NA-098

Subject: Armrest Does Not Lock in Position and Slides Back and Forth

Brand:	Model:	Model Year:		Vehicle Build Breakpoint Date:		Engine:	Transmission:
		from	to	from	to		
Chevrolet	Tahoe Models Suburban	2021	2022	SOP	October 1, 2021		
GMC	Yukon Models

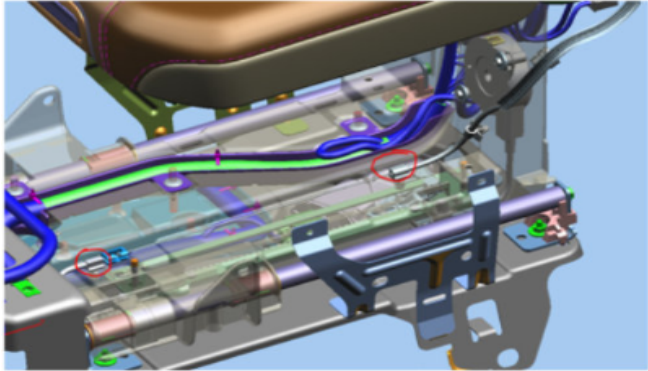
Involved Region or Country	North America
Condition	Some customers may comment on the armrest sliding back and forth and that the armrest does not lock in the intended position.
Cause	<div style="background-color: black; width: 100%; height: 20px; margin-bottom: 5px;"></div>

<div style="background-color: black; width: 100%; height: 20px; margin-top: 5px;"></div> <p style="text-align: right; font-size: small;">6065371</p>
Correction	Verify clip is installed fully and clean areas around clip to fully correctly fully seat.
