Subject: Engineering Information - Oil Leaking From Oil Pan

Brand:	Model:	Model Year:		VIN:		Engine:	Transmission:
		from	to	from	to		
Chevrolet	Silverado 1500 New (RPO J22, 12th VIN Digit = 5 or greater)	2022	2022	December 01, 2021	May 01, 2022	Equipped with 2.7L Engine (RPO L3B)	—
GMC	Sierra 1500 New (RPO J22, 12th VIN Digit = 5 or greater)

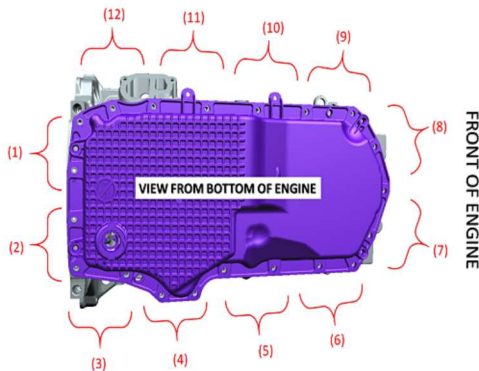
1. Visually inspect oil pan to identify traces of residual oil collection, and trace the leak path to the highest point (check if this is the oil pan to LCE joint).
2. If leak seems to be from oil pan to LCE joint, wipe excess oil and add engine dye.
3. Put additional miles on vehicle, and re-inspect with a black light to confirm that source of leak is in fact the oil pan to LCE joint.
4. If dye is detected, take clear snapshots of leak location / path at the oil pan to LCE joint.

5. Make an assessment on which leak "zone" 1-12, as shown in the picture above, that the oil is originating from when contacting the engineer.
6. Take clear close up pictures of both, inside the oil pan and where the RTV is adhered too and a picture looking up at the bottom of the engine upon the oil pan removal.
