JLRTB02100NAS1

TECHNICAL BULLETIN

Rear Window and Rear Proximity Camera Wash Not Operating

MODEL:	MODEL YEAR:	VIN:	ASSEMBLY PLANT:
Range Rover (LK)	2022	000255-001600	Solihull

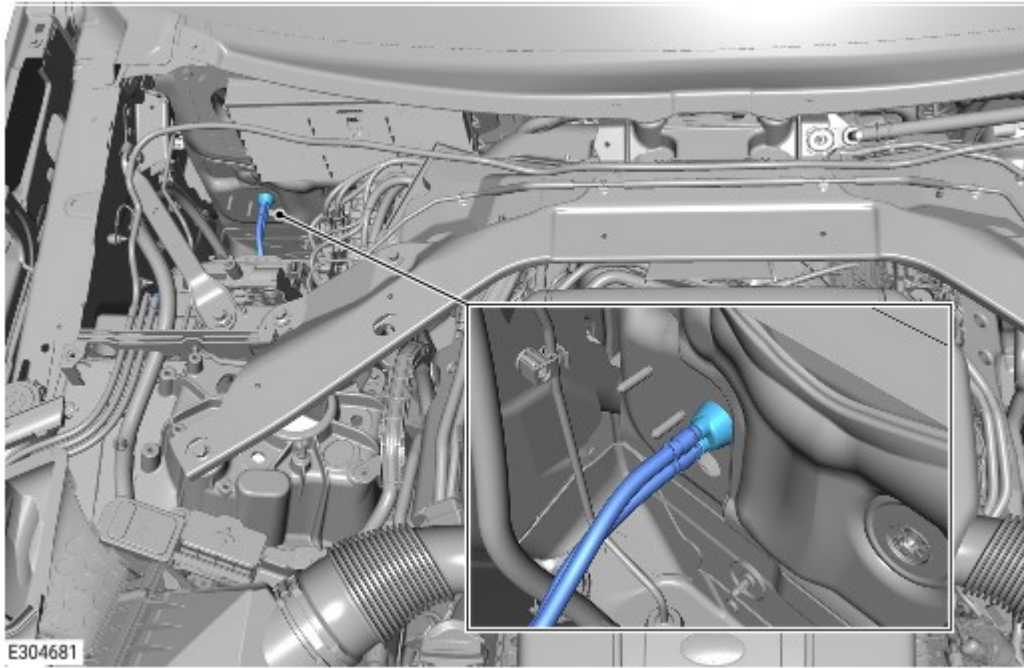
2.

This image shows the location of the rear washer intermediate connector grommet.

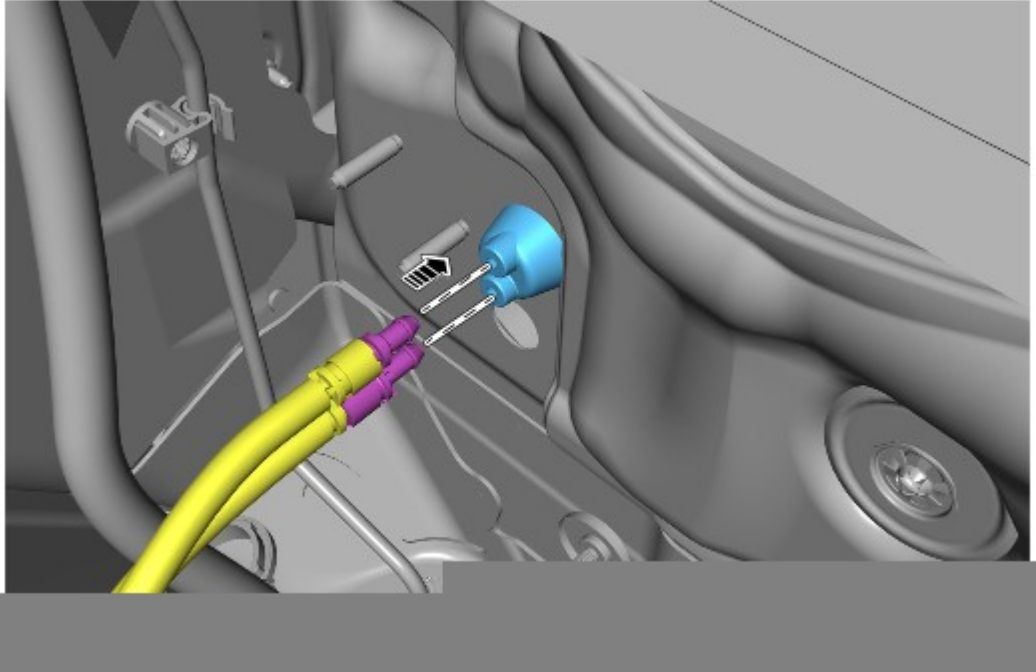
3.

Make sure both rear washer hoses are fully installed in the intermediate connector grommet.

If 1 or both of the rear washer hoses are uninstalled from the intermediate connector grommet, reinstall the hose(s) in the correct location.

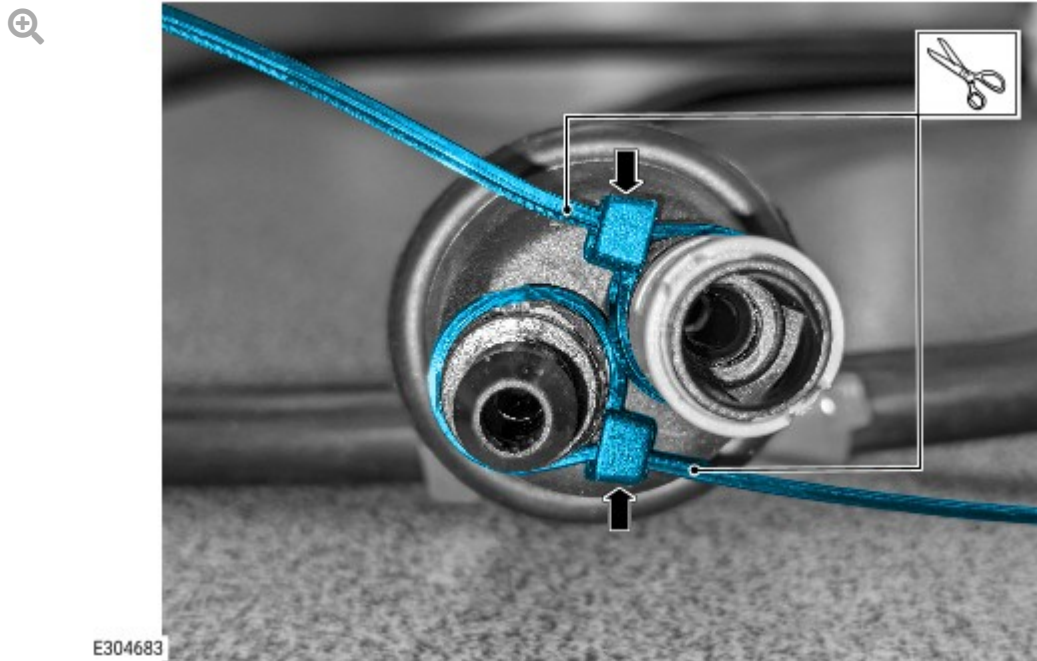
4.

The cable ties must be installed in the positions shown in the image.

To secure the rear wash hoses, install 1 cable tie around each intermediate connector inlet on the grommet, as shown in the image.

- Use a suitable tool to remove the excess from the cable ties.
