RECALL ACTION

Global Recall Action
Number: N685

Subject: Front Impact Sensor Torque Check	Publication No.: N685
	Model: Range Rover (LK)
	Model Year: 2022
	Date of Issue: 20 May 2022

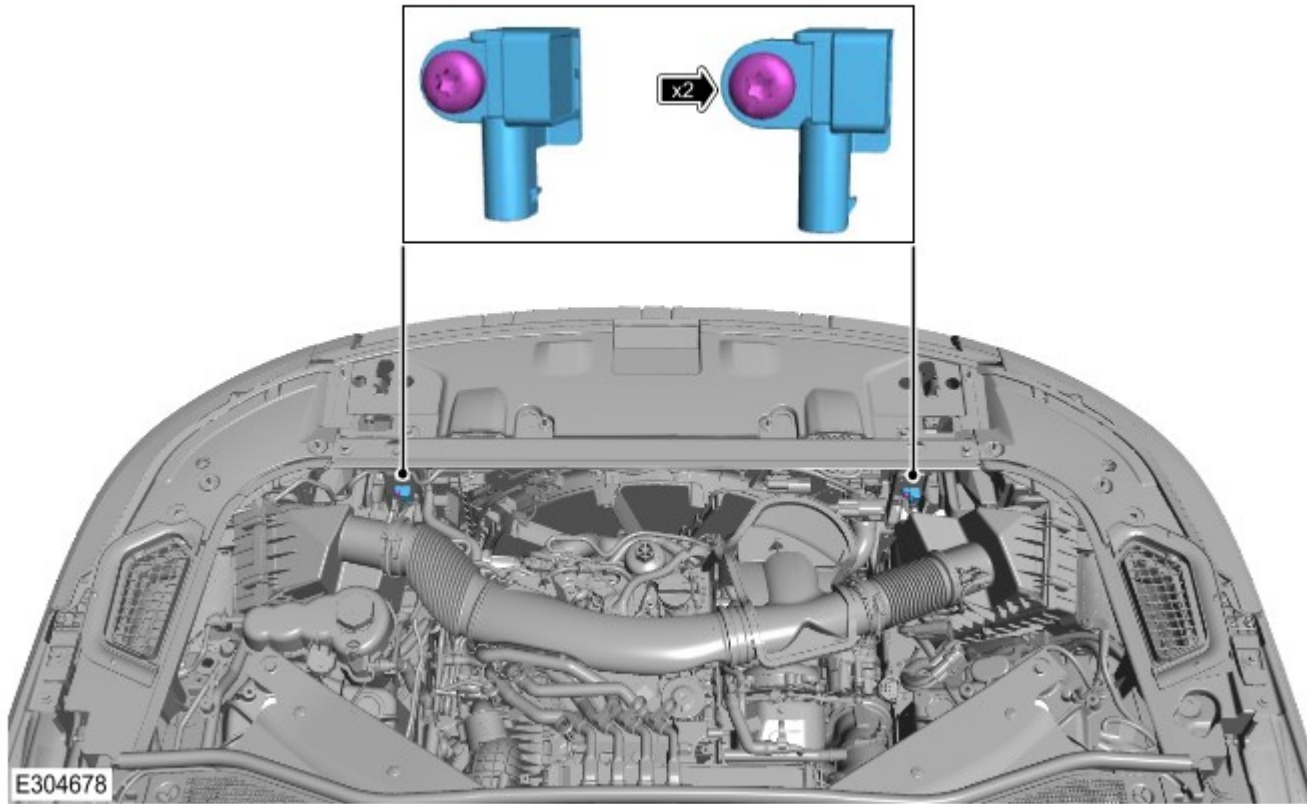
A concern has been identified on certain 2022 model year New Range Rover vehicles where the front crash sensor fixings may not have been installed to the specified level of torque. There is a risk that the front crash sensors may become loose resulting in incorrect operation of the active restraints system. This could lead to increased occupant injury or, in the case of inadvertent frontal airbag deployment, loss of vehicle control increasing the risk of a crash.

The investigation conducted revealed a manual error was made during the assembly of some vehicles where the fixings were only partially fixed (by hand only) and the manufacturing operation was not completed. The error was found to be human error.

2. Locate and torque the 2 impact sensor bolts.

- Torque: **10 Nm**
