# Service Bulletin

Bulletin No.: 19-NA-257

**Subject:** Pickup Box Out of Alignment

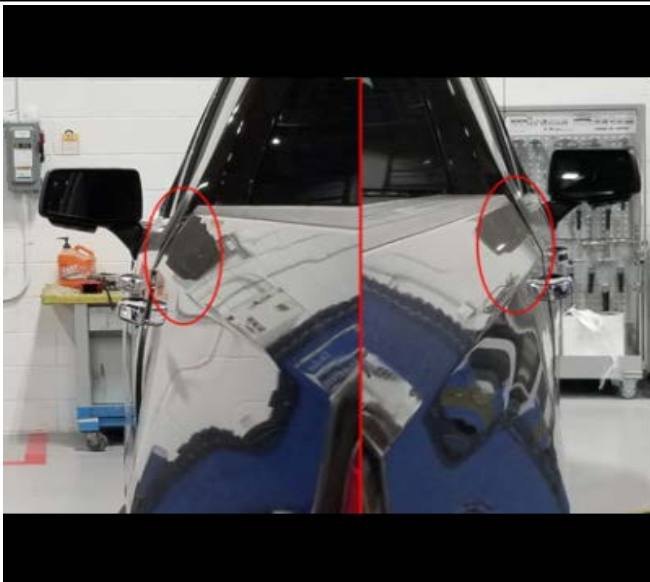
| Condition | <p>5442974</p> <p>The pickup box appears to be out of alignment from side to side of the truck. The condition is more noticeable from rear of truck, down the side.</p> |
| Cause | The cause of the condition may be the pickup box was misaligned from the assembly plant. |

| Correction | Adjust the pickup box to within tolerance, following the steps in the Service Procedure below. |

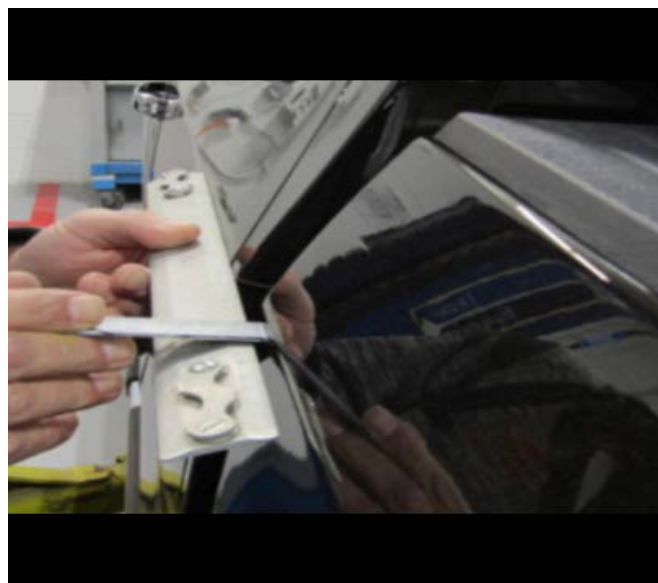
5442975

**Note:** Measure the cab to box distance on both sides of the vehicle.

- Using a straight edge on the side of the cab corner at the upper body line, measure the distance to the pickup box. The box should be sub-flush with cab and within 2.5 mm (0.10 in) total difference side to side.
  - If the box is sub-flush AND the distances ARE within the 2.5 mm (0.10 in) range side to side, no box alignment is necessary.
  - If the box IS NOT sub-flush AND the distances ARE NOT within the 2.5 mm (0.10 in) range side to side, continue on to the box alignment procedure.

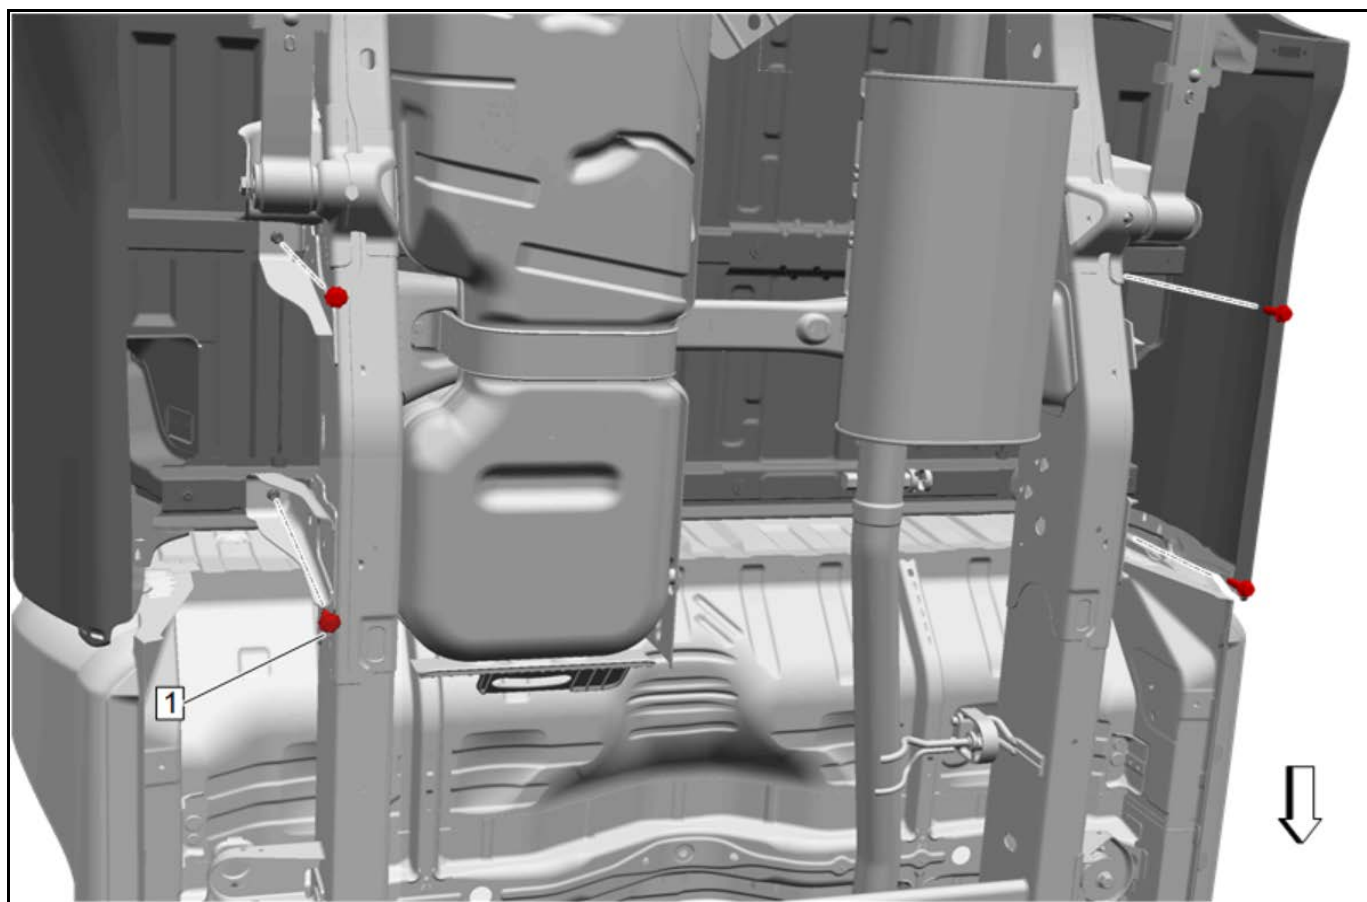
4998459

**Note:** Long pickup box shown above, has 4 front bolts, short box only has 2.

4. Remove the **front** pickup box bolts (1) and clean any sealer that may prevent movement between the bolt and frame. Reinstall the bolts and hand turn a couple of turns.

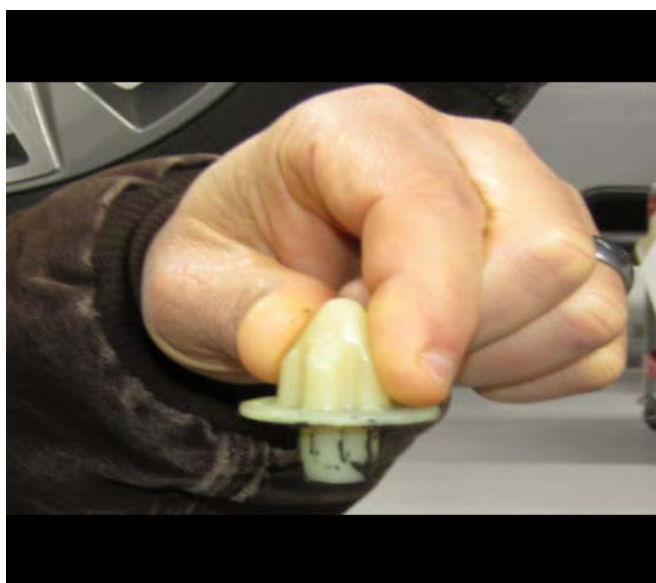
5442977

**Note:** If box alignment is limited due to locating pins in the bed preventing correct alignment, the front locating pin can be removed.

5. Remove the front bed to frame locator pin, as necessary.
6. Align the pickup box to within specifications. Box should be sub-flush with cab and within 2.5 mm (0.10 in) total difference side to side.
7. Tighten all pickup box bolts. Refer to Fastener Specifications in the Body Repair section in SI, for proper Torque specifications
8. Remove any tape/protection that was applied.
