# Service Bulletin

Bulletin No.: 20-NA-142

**Subject:** Shudder/Surging While Driving

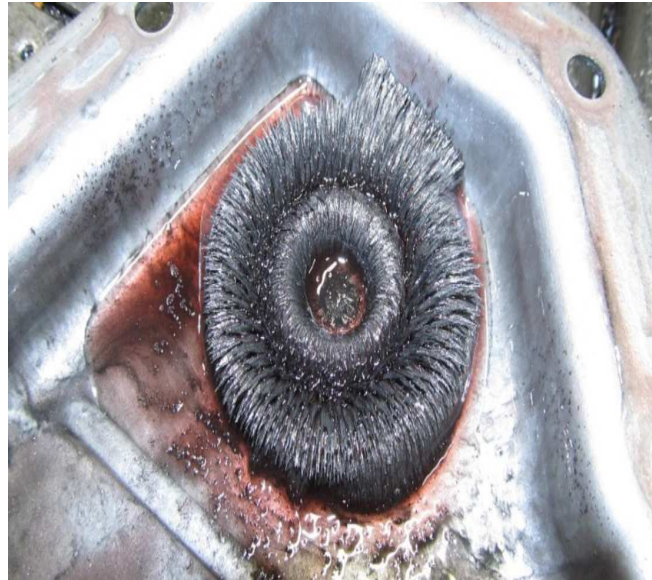
5360216

- If metallic debris is present (similar to graphic above), remove transmission and replace the torque converter and replace the transmission filter. Refer to *Torque Converter Replacement in SI*.

- If metallic debris is not present drain and clean the oil pan and reinstall transmission oil pan.
3. Fill the transmission with 6 quarts of DEXRON VI Transmission Fluid following published Service Information.
