Limited PCM Function due to Excess Temperature: Checking Installation Position of PCM Central Computer (46/22)

Model Line: **911 (992)**

Model Year: **As of 2021 up to 2022**

Concerns: **Holder for PCM central computer**

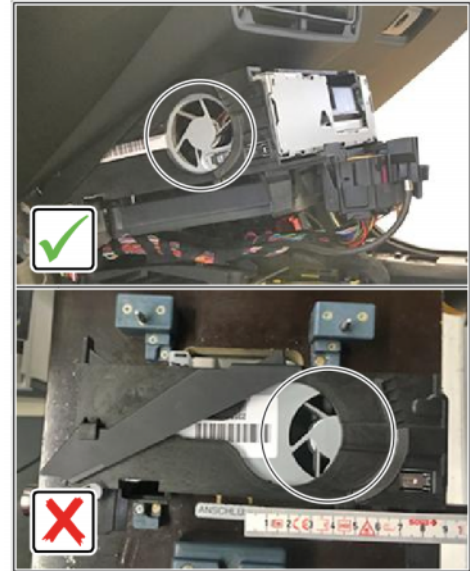
Holder for PCM central computer

Information: There is a possibility that holders for the PCM central computer that were installed during series production are not suitable for the respective type of computer. If the combination of PCM central computer and holder is incorrect, the fan of the PCM central computer is covered by the holder. This can cause the PCM central computer to overheat.

Work Procedure: 1 Check whether the fan of the PCM central computer is covered by the holder ⇒ *Holder for PCM central computer*.

- If the fan of the PCM central computer is free and is not covered by the holder ⇒ *Holder for PCM central computer*, continue with ⇒ *Technical Information '68171900 Concluding work'*. The complaint must be found in some other way and corrected.
- If the fan is covered by the holder ⇒ *Holder for PCM central computer*, replace the holder for the PCM central computer. For instructions, see: ⇒ *Workshop Manual '915219 Removing and installing central computer'*

Action required: In the event of a complaint, check whether the fan of the PCM central computer is covered by the holder. If the fan is covered, replace the holder for the PCM central computer.

Part No.	Designation – Location	Number
N 91026201	⇒ Hexagon collar nut, M10 - Rear belt buckle	2 units
Additional parts required if the holder for the PCM central computer has to be replaced:		
992857114A	⇒ Support – PCM central computer (M-no. I8L)	1 unit
or		
992857114B	⇒ Support – PCM central computer (M-no. I8Z)	1 unit
