**Taycan: Vehicle Unlocks Itself Immediately After Locking with Comfort Access**

Models	Model Year	Model Type	VIN Range	Vehicle-Specific Equipment
Taycan	2022	Y1A/ Y1B/ Y1C	N/A	N/A

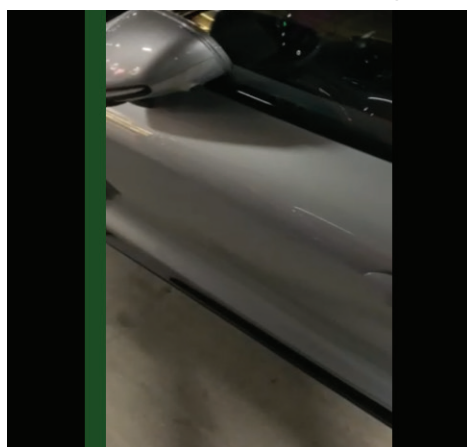
**Figure 1: Vehicle Locking After Unlocking**

Customer states that the vehicle locks itself immediately after locking via the Comfort Access feature (see Figure 1). This is sometimes possible with both the front and rear door handles. Proper function of the system may be possible after at least one additional attempt to lock the vehicle.
