**Taycan: Buzzing noises from the area of the steering column**

**Vehicles Affected**

Models	Model Year	Model Type	VIN Range	Vehicle-Specific Equipment
Taycan	As of 2020	Y1A/ Y1B/ Y1C	N/A	N/A

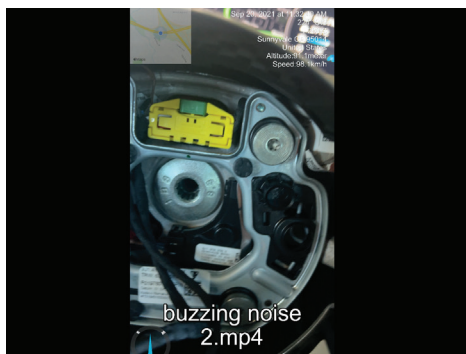
**Figure 1: Example noise heard inside the cabin**

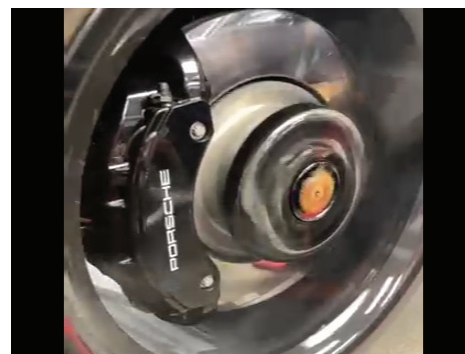
**Figure 2: Example noise heard on the lift**

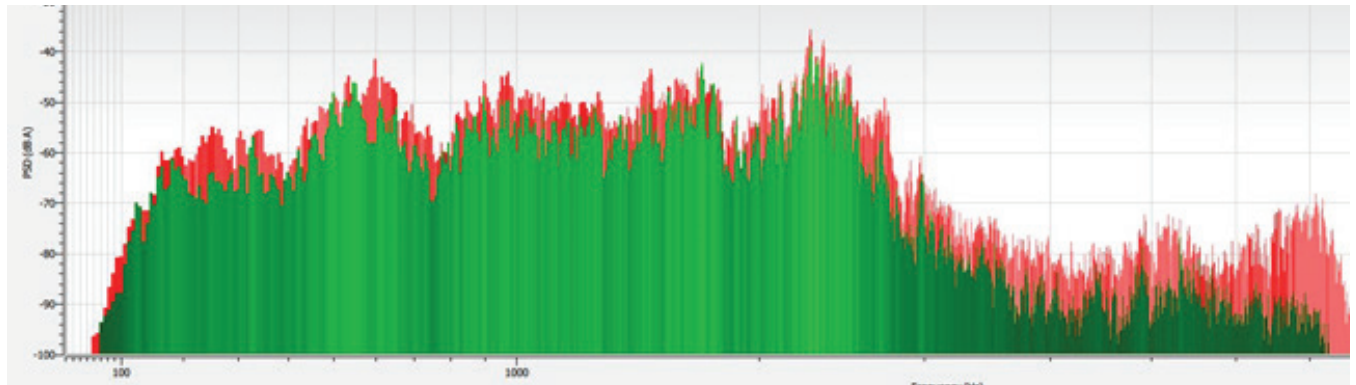
1. Capture an FFT plot of the noise. The noise should be approximately 2200-2500 Hz

**Figure 3: Example FFT Plot from Inside the Vehicle**

2. Raise the vehicle on a lift and drive the wheels. If the noise persists (audible either inside or outside the vehicle, or both), it is likely related to one or both of the front wheel bearings.
3. Verify which wheel bearing(s) is (are) causing the noise by attaching the chassis ears to the steering knuckles. Replace the affected wheel bearings.
4. Capture a second FFT plot to verify that the noise is no longer present. Please attach the FFT plot image to the PCSS job and/or PRMS ticket.
5. Please attach pictures of any replaced wheel bearings to the PCSS job and/or PRMS ticket.
