**Taycan: Vehicle Unlocks Itself Immediately After Locking with Comfort Access**

**Vehicles Affected**

Models	Model Year	Model Type	VIN Range	Vehicle-Specific Equipment
Taycan	2022	Y1A/ Y1B/ Y1C	N/A	N/A

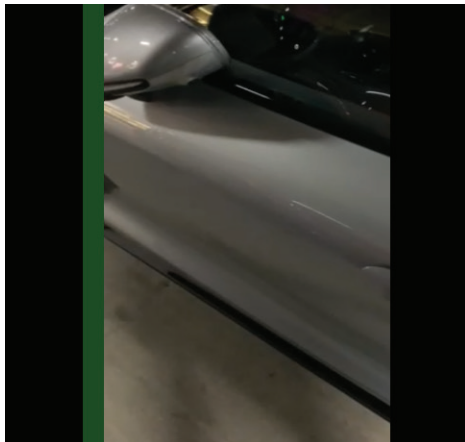
**Figure 1: Vehicle Locking After Unlocking**

Customer states that the vehicle locks itself immediately after locking via the Comfort Access feature (see Figure 1). This is sometimes possible with both the front and rear door handles. Proper function of the system may be possible after at least one additional attempt to lock the vehicle.

This issue may be caused by the incorrect positioning of the printed circuit board (PCB) inside the door handle body. An incorrect position of the PCB may cause the door handle to continuously transmit unlocking requests after locking the vehicle via the touch sensor on the outside of the handle.

The current countermeasures will optimize the manufacturing process of inserting the PCB into the door handle body, as well as further software optimization for enhanced signal filtering. As of May 5, 2022, both of these countermeasures are expected by the end of May 2022.

4. Take pictures of the manufacturing stamps on the back of **all 4 door handles** (Figure 3) **and attach them to the PCSS job.**
5. Replace **only** the door handles which exhibit this condition as per *WM 571119 – Removing and installing door handle (front)* or *WM 581119 – Removing and installing door handle (rear)*.
