WMJ2 - Rework on Threaded Joint for Ground Point (Workshop Campaign)

Model Line: **911 (992)**

Model Year: **As of 2020 up to 2022**

Concerns: **Threaded joint securing ground point to body**

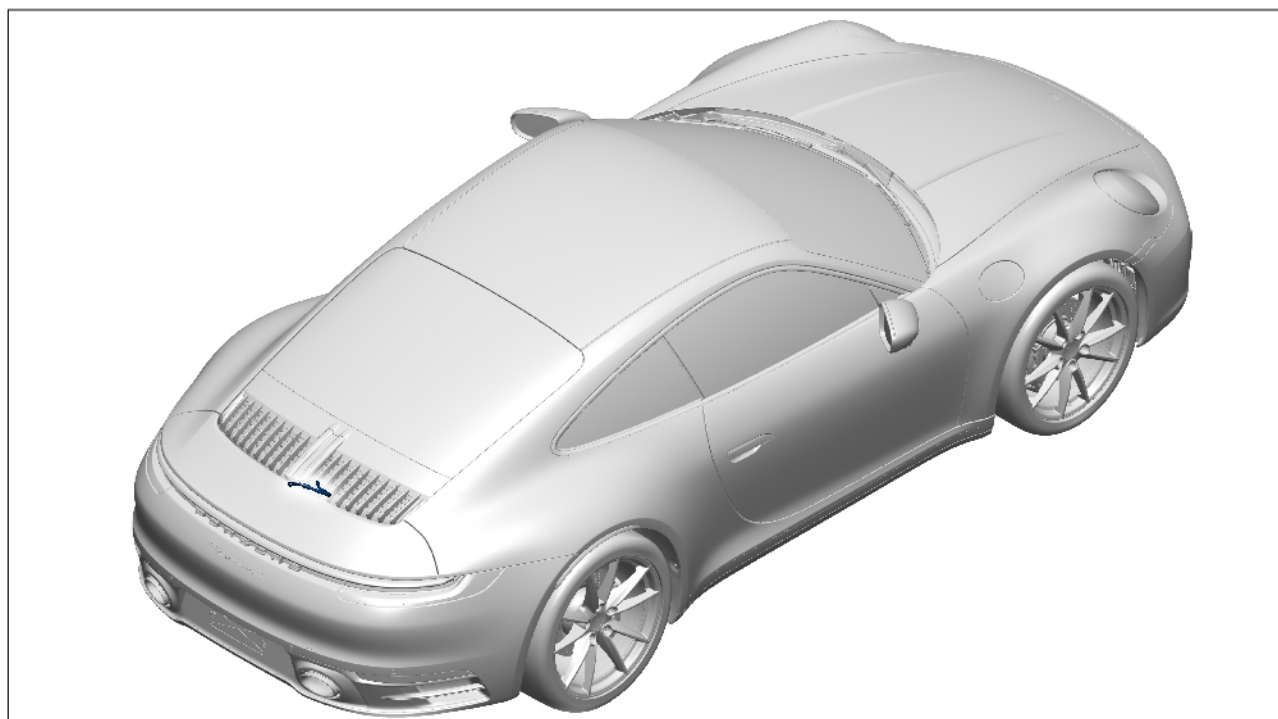
Ground strap installation position

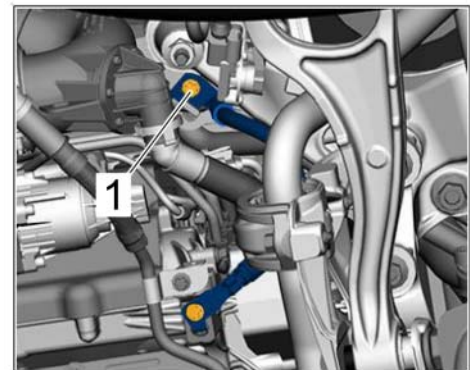
Fastening screw for ground strap

Work Procedure: 1 Unscrew fastening screw ⇒ *Fastening screw for ground strap -1-* on the ground strap.

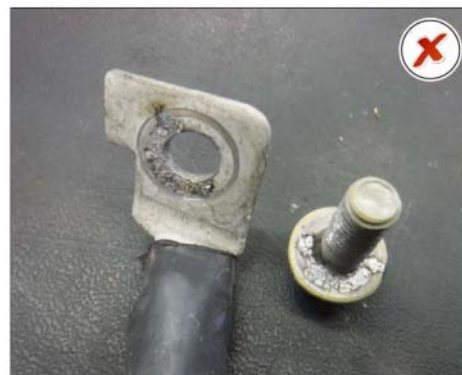
- 2 Check the contact surface of the ground strap for corrosion and damage. ⇒ *Fault type – ground strap and ground screws*

Fault type – ground strap and ground screws

Assessment		Action
(✓)	Contact surface on ground strap is OK .	Brush off contact surface of the ground strap or clean with sandpaper. Install new fastening screw ⇒ <i>Fastening screw for ground strap -1-</i> and tighten Tightening torque 23 Nm (17 ftlb.) . ⇒ <i>Workshop Manual '978719 Removing and installing ground strap for engine'</i>
(x)	Contact surface on ground strap is not OK	Install new ground strap , Part No. V04015001EH with the new fastening screw ⇒ <i>Fastening screw for ground strap -1-</i> . Check that the tightening torque is correct. Tightening torque 23 Nm (17 ftlb.) ⇒ <i>Workshop Manual '978719 Removing and installing ground strap for engine'</i>
