**Taycan: Vehicle Unlocks Itself Immediately After Locking with Comfort Access**

Models	Model Year	Model Type	VIN Range	Vehicle-Specific Equipment
Taycan	2022	Y1A/ Y1B/ Y1C	N/A	N/A

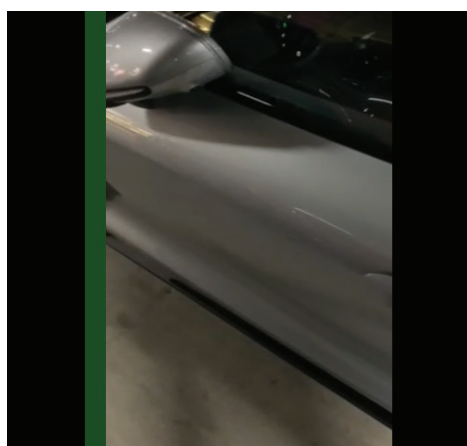
**Figure 1: Vehicle Locking After Unlocking**

Customer states that the vehicle locks itself immediately after locking via the Comfort Access feature (see Figure 1). This is sometimes possible with both the front and rear door handles. Proper function of the system may be possible after at least one additional attempt to lock the vehicle.

This issue may be caused by the incorrect positioning of the printed circuit board (PCB) inside the door handle body. An incorrect position of the PCB may cause the door handle to continuously transmit unlocking requests after locking the vehicle via the touch sensor on the outside of the handle.

The current countermeasures will optimize the manufacturing process of inserting the PCB into the door handle body, as well as further software optimization for enhanced signal filtering. As of May 12, 2022, both of these countermeasures are expected by the end of May 2022.
