**Engine Symptom – Rough-Running Engine and Engine Indicator Light Has Come On:  
Re-Programming DME Control Unit (SY 07/22)**

Model Line: **Macan (95B)**

Equipment: **2.0-liter 4-cylinder petrol engine (engine type: EA888)**

Concerns: **Engine electronics (DME) control unit**

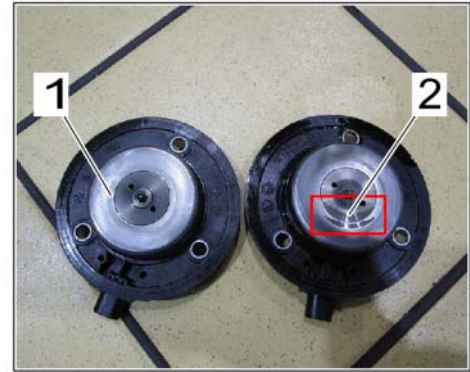
*Appearance of scoring and seizure marks on the actuator for the camshaft controller*

2 Check the actuator for the camshaft controller of the intake camshaft for scoring and seizure marks.

2.1 If the actuator for the camshaft controller of the intake camshaft does not ⇒ *Appearance of scoring and seizure marks on the actuator for the camshaft controller -1-* have any scoring or seizure marks, check the intake camshaft actuator and the intake camshaft itself for scoring and seizure marks as well. To do this, continue with Step 3.

2.2 If the actuator for the camshaft controller of the intake camshaft ⇒ *Appearance of scoring and seizure marks on the actuator for the camshaft controller -2-* has scoring or seizure marks, continue with ⇒ *Technical Information '153919 Replacing intake camshaft'*.

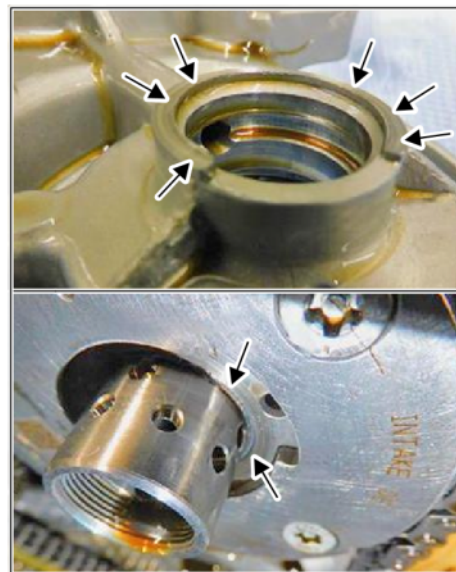
*Appearance of scoring and seizure marks on the camshaft actuator*

4 Check the intake camshaft actuator for scoring and seizure marks.

The axial play of the intake camshaft is not guaranteed if the spacer of the intake camshaft actuator shows signs of wear.

- 5 Check the intake camshaft for scoring and seizure marks.
  - 5.1 If the intake camshaft and the actuator do not have scoring or seizure marks, the fault will need to be located and remedied another way. In this case, discuss and agree on how to proceed with your Technical Support contact. For information on the subsequent work required for completing the vehicle, see ⇒ *Technical Information '158419 Concluding work after checking or replacing the intake camshaft'*.
  - 5.2 If the intake camshaft or the actuator has scoring or seizure marks, continue with ⇒ *Technical Information '158419 Replacing intake camshaft'*.

- Work Procedure: 1 Replace the intake camshaft and damaged accessories.  
 For instructions, see:  
 ⇒ *Workshop Manual '158219 Removing and installing cylinder head cover'*
- 2 Replace oil filter.  
 For instructions, see:  
 ⇒ *Workshop Manual '173055 Replacing oil filter (R4)'*
