# Technical product information

<b>Topic</b>	Bentayga Hybrid - Drive Motor Position Sensor - DTC P0C5*00
<b>Market area</b>	Bentley: worldwide (2WBE)
<b>Brand</b>	Bentley
<b>Transaction No.</b>	2059027/4
<b>Level</b>	EH
<b>Status</b>	Approval
<b>Release date</b>

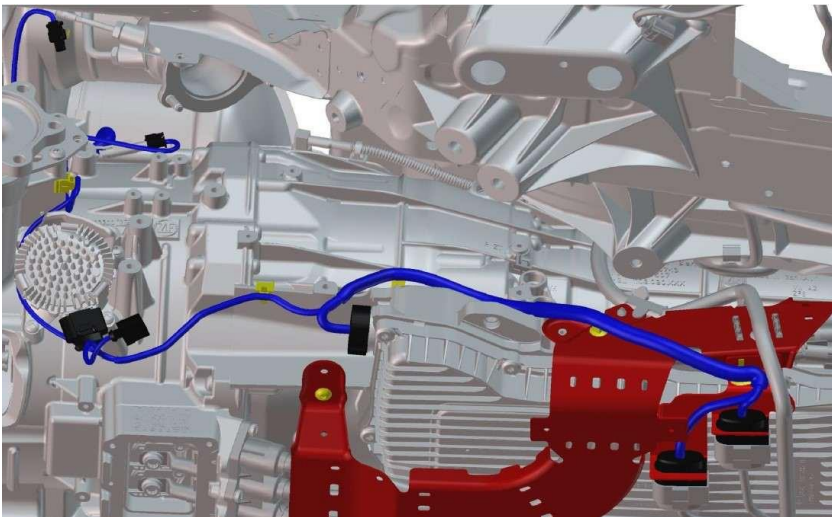
Figure 1

DTC's - P0C5\*00 - may be set within address 51 - *Drive Motor Control Module* If the transmission 12 Volt harness becomes damaged or there are unsatisfactory electrical connections within the connector for *Drive Motor Position Sensor*.

With DTC's P0C5\*00 stored in address 51 - *Drive Motor Control Module* inspect the 12 Volt transmission harness for external damage – *figure 1*. Check the integrity of the connector terminals for the *Drive Motor Position Sensor* – *figure 2* - with respect to the transmission 14 way interconnect.

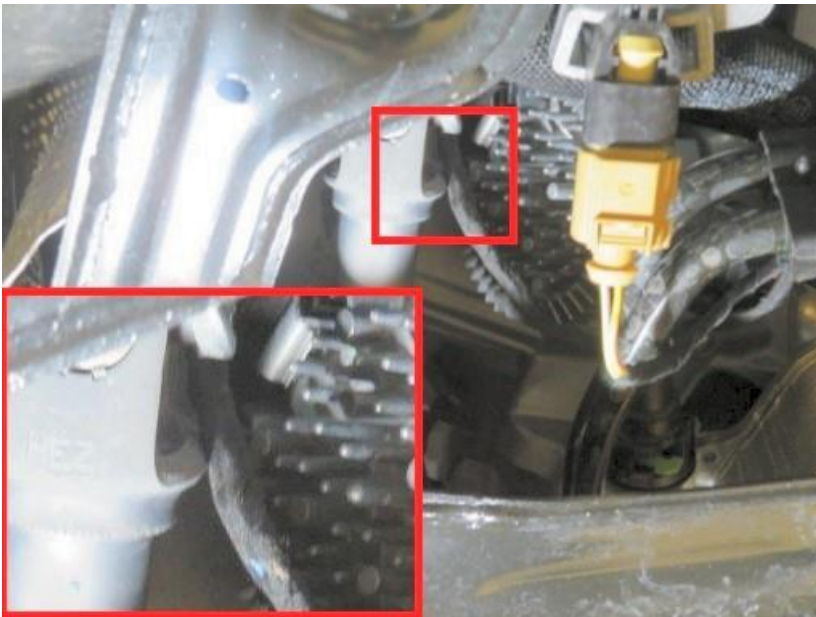
Figure 3

Note: On Left hand drive vehicles the transmission harness may foul the lower steering column – figure 3. If a foul condition exists or the harness is in close proximity to the steering column, visually check the harness for damage, if damage is not present move the excess harness to the side of the Clutch Actuator Unit – figure 4 - excess harness should be secured to the Clutch Actuator Unit connector using a suitable cable tie – figure 5.
