Service Alert

INFOTAINMENT SYSTEM CONTINUOUSLY REBOOTS NEAR
SEATTLE WASHINGTON

Service Alert No.: SA-005/22

Last Issued : 05/04/2022

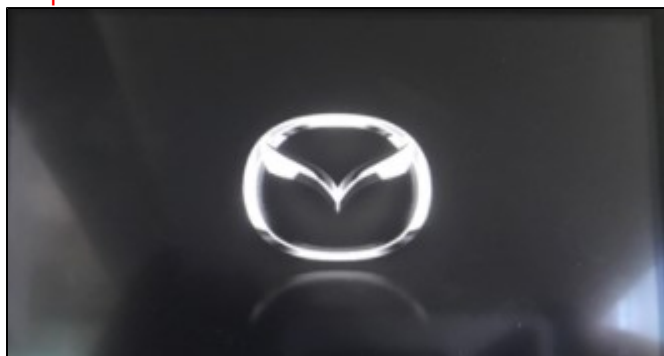
Some customers may experience a continuous infotainment reboot in or near Seattle Washington and troubleshooting is not possible due to continuous reboot.

1. Verify customer concern.
2. Replace the CMU.
3. Verify repair.
