Complaint – Porsche Communication Management (PCM) does not Work: Reset Central Computer (93/21)

Revision: This bulletin replaces bulletin Group 9 93/21, dated July 15, 2021.

Model Year: **As of 2019 up to 2021**

Model Line: **Macan (95B)**

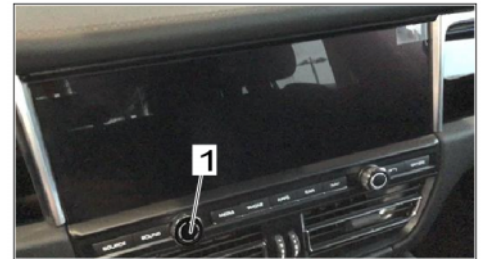
Volume control PCM

Information: Porsche Communication Management (PCM) cannot be switched on and the central computer cannot be controlled using the PIWIS Tester.

This fault type can occur after an undervoltage in the on-board electrical system. The central computer goes into an undervoltage protection mode when doing this.

Action required: Reset the central computer. To do this, hold down the volume control ⇒ *Volume control PCM-1* - for ten seconds when the ignition is switched on.
