Subject: DTC B1495:87 STORED AND CANNOT BE ERASED AFTER ACCESSORY TRAILER HITCH IS INSTALLED	Service Alert No.: SA-030/22
	Last Issued : 05/05/2022

2020-2022 CX-9 (Grand Touring and Signature)

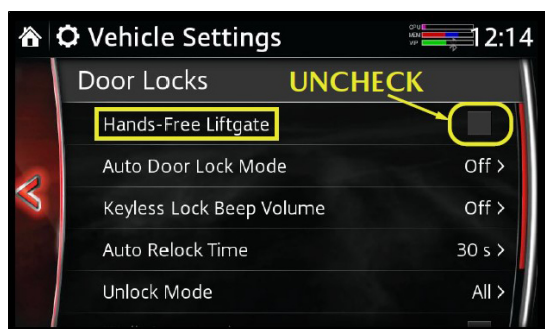
- Advise the customer that they will no longer have the handsfree sensor function after trailer hitch installation.
- Advise the customer to leave the Hands-Free Liftgate "unchecked".
