| Subject: 16" AND 17" TIRE SIDEWALL DISTORTION | Service Alert No.: SA-031/22 |
| | Last Issued : 05/06/2022 |

APPLICABLE MODEL(S)

| 2021-2022 Mazda3 | 2021 Mazda6 | 2021-2022 CX-30 | 2021-2022 CX-5 |

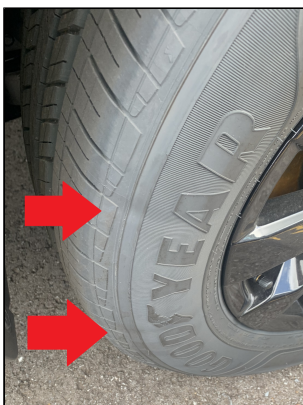
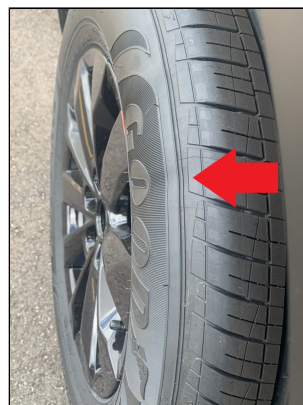
Sidewall Indentations / Undulations

Sidewall waviness/indentations/undulations are common on radial tires and are more noticeable on tires with taller sidewalls. The higher the tire pressure, the more noticeable the effect will be. Be sure to set the tire pressures at the recommended tire pressure on the vehicle tire label.

Sidewall indentations are a cosmetic condition that does not affect the performance of the tires.

Tires are reinforced by multiple fabric cords encased in a thin sheet of rubber. Radial ply tires feature one or more layers of these sheets running parallel to each other from bead to bead. The sheets overlap where they meet. When the tire is mounted and inflated to operating air pressures, it is free to expand. The overlapped splices may create slight indentations since they stretch slightly less than the rest of the sheet. In reality, the splices are the most reinforced area of the tire's sidewall.

Because radial tires feature steel cord reinforcing belts under the tread to keep them smooth, indentations only appear on the sidewalls.
