# Service Alert

**TELEMATICS COMMUNICATION UNIT (TCU) ACTIVATION  
PROCEDURE**

**Service Alert No.: SA-034/22**

**Last Issued : 05/20/2022**

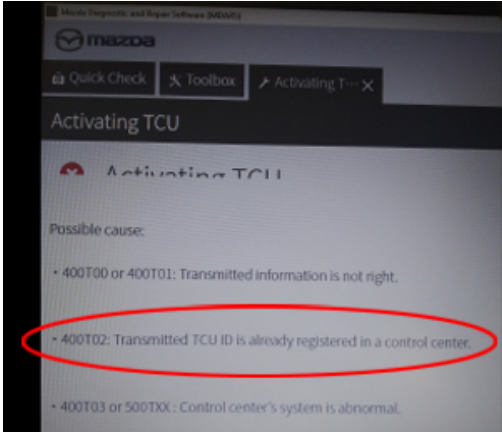
ERROR:05	Error code 400t02

- If DTC U2050:55-TCU (Activation of remote control not implemented) is stored, go to TSB [09-013/20 - DTC U2050:55 STORED AFTER REPLACING OR REPROGRAMMING TCU](#).
- If the TCU was not replaced and MDARS shows error code 400t02 and/or ERROR:05, TCU activation was previously completed. Ignore these errors as TCU activation is not required.
