Subject: REAR BUMPER DISTORTED	Service Alert No.: SA-035/22
	Last Issued : 05/20/2022

2023 CX-50

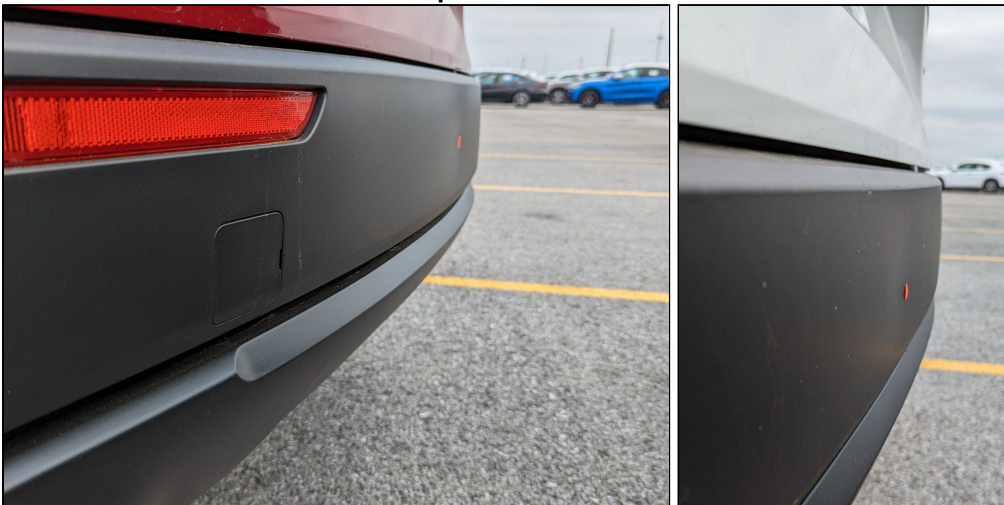
During PDI, an indentation in the rear bumper may be noticed, and in some cases, the customer may return after delivery to report the indentation.

Inspect the rear bumper for an indentation in the same location (red dot) on the bumper as in the examples shown below?

Is there an indentation on the bumper?

DO NOT REPLACE THE REAR BUMPER.

YES: DO NOT replace the rear bumper at this time. This condition is currently under review and repair information will be forthcoming.
