TECHNICAL SERVICE BULLETIN

Classification: AT22-003	Reference: ITB22-018	Date: April 19, 2022
-----------------------------	-------------------------	-------------------------

“SERVICE AT POWER REDUCED” WARNING DISPLAYED AND DTC P0715 STORED IN THE TCM

APPLIED VEHICLES: 2022 QX60 (L51)
APPLIED DATES: Built before March 21, 2022

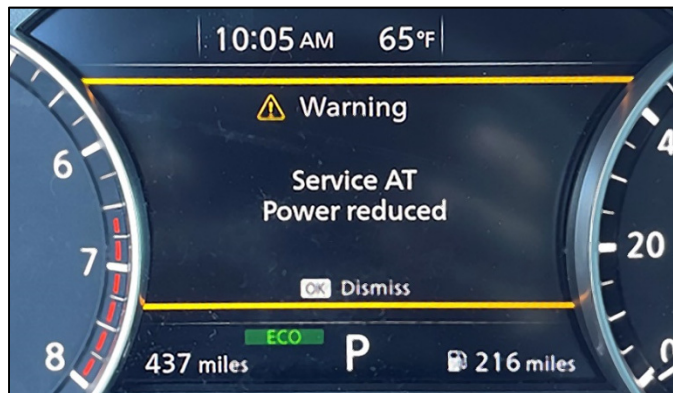
Figure 1

The client states the “Service AT Power reduced” warning message (Figure 1) is/was displayed,

DTC P0715 (INPUT SPEED SENSOR A) is the only DTC stored in the TCM.

1. Confirm the current TCM part number.
2. Reprogram the TCM, if applicable.
