### Articles Contained in this Issue

# TECH TIPS GREATEST TIPS

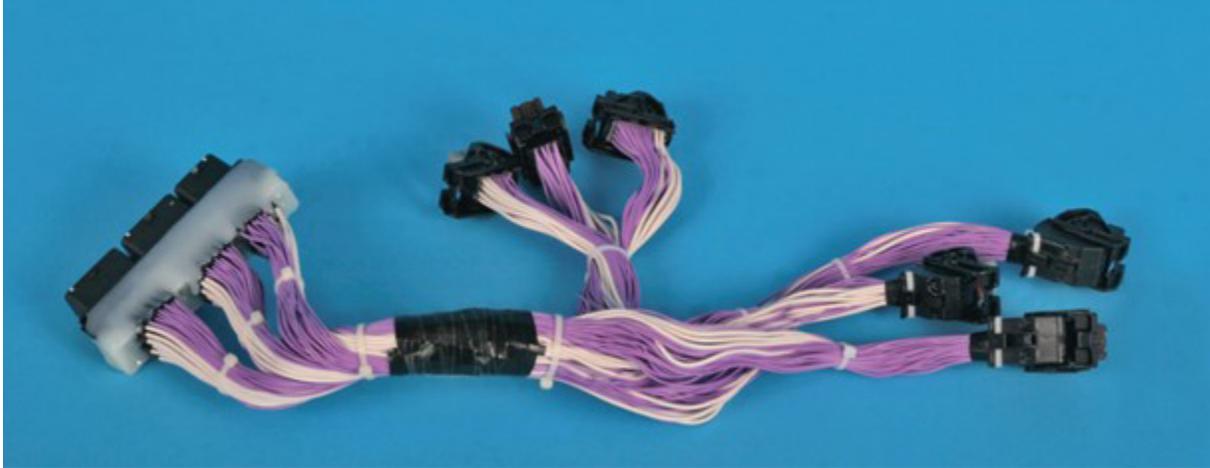
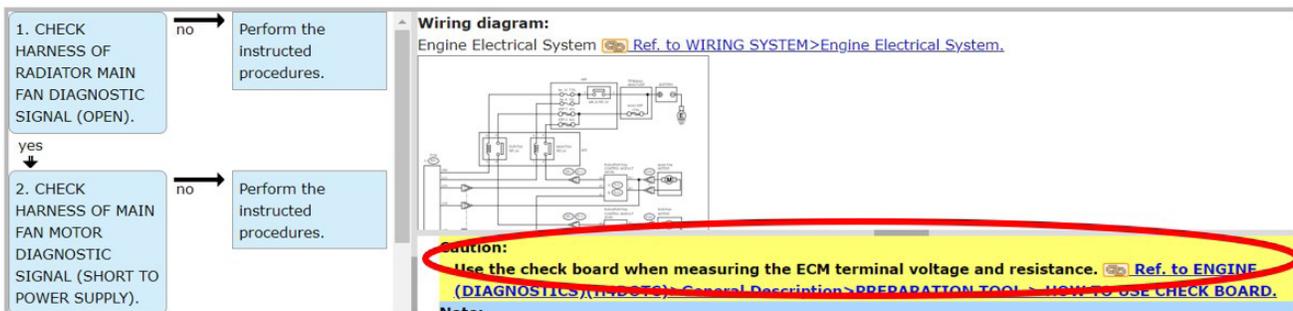
Every year more and more vehicles require check board harnesses to complete proper diagnostics. Recently, Techline and Field Quality Assurance have become aware that Technicians are not using these diagnostic tools correctly.

Modern vehicle wiring has gotten smaller. It is more important than ever to use the dedicated Check Board Harness for testing. There is potential to damage the vehicle's wiring harness if the proper testing procedure is not followed. Failure to do so can lead to new concerns caused by damage to the harness or module. It is good practice to mark/identify the testing portion of the Check Board Harness so one end is used for testing while the other end is reserved for plugging into the vehicle. This will prevent possible damage to the vehicle while perform testing and diagnostics.

**Caution:**  
Use the check board when measuring the ECM terminal voltage and resistance. [Ref. to ENGINE \(DIAGNOSTICS\)\(H4DCTC\) General Description>PREPARATION TOOL>HOW TO USE CHECK BOARD.](#)

The Service Manual will display a caution note if a Check Board Harness is necessary. The CAUTION/NOTE tab can also be used to identify the need for check board harness.

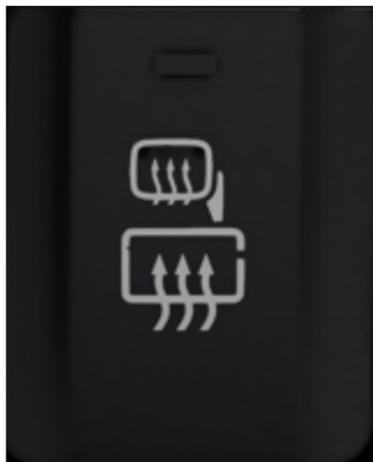
86213VC410

The new 2022 WRX has two base model options for CP1. The Cockpit Information Display (CID) can be easily misidentified when attempting to make repairs. The main method to determine which CID is installed is to inspect the Heated Mirror Switch on the bottom left-hand corner of the unit. Note in the pictures below if a heated mirror option is equipped it will be shown on the button.

**With** Heated mirror switch

The part numbers are also different, and the CID should not be interchanged with the opposite unit. The part number has now been included on the back of the unit if there is an unusual circumstance.

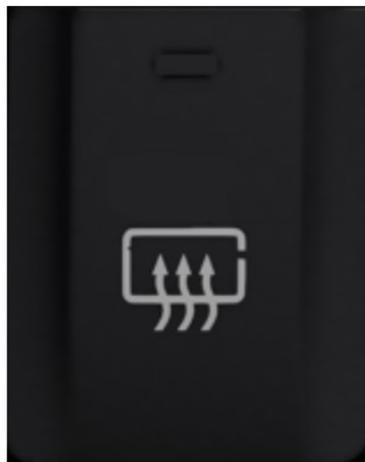
86213VC430

**Without** Heated mirror switch

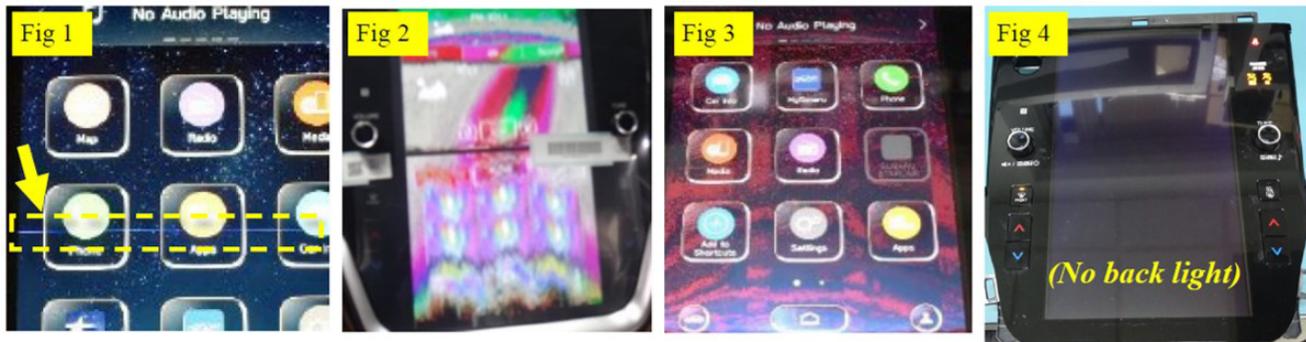
Techline has identified four examples of failed CID (Cockpit Information Displays). These are the typical concerns of a failed CID.

- **Figure 1:** shows a thin pixel line across the screen at all times. This can develop anywhere on the screen.
- **Figure 2:** shows full color failure. The screen will always look disfigured and unusable.
- **Figure 3:** is a different variation of color failure, it will look patchy or as if the back light has failed in certain spots.
- **Figure 4:** is a total loss of image. This condition should not be confused with temporary blackout. This condition will not power up the screen in any way regardless of key position or input. Note that Airbag indicators still function. Volume and Temperature controls may still work if the blower is on at the time. Power and ground should be verified, and then the best course of action is swapping the CID with a known good unit of the same trim level (mid or high).

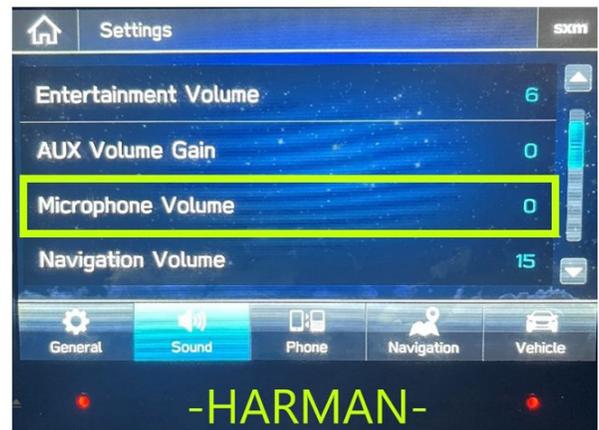
On Harman models, if the setting **Microphone Volume** is turned up or down, these conditions can occur. The setting has very little to do with the loudness of the call. In actuality it adjusts how sensitive the microphone is. A **Microphone Volume** with a +30, will have a lot of “wind noise” or static. The microphone is too sensitive and is picking up every noise inside the cabin. If the setting is -30, the caller will not be heard at all when talking. Small adjustments can be made in one or two increments, but Techline has not seen a phone that requires more than 4 adjustments.

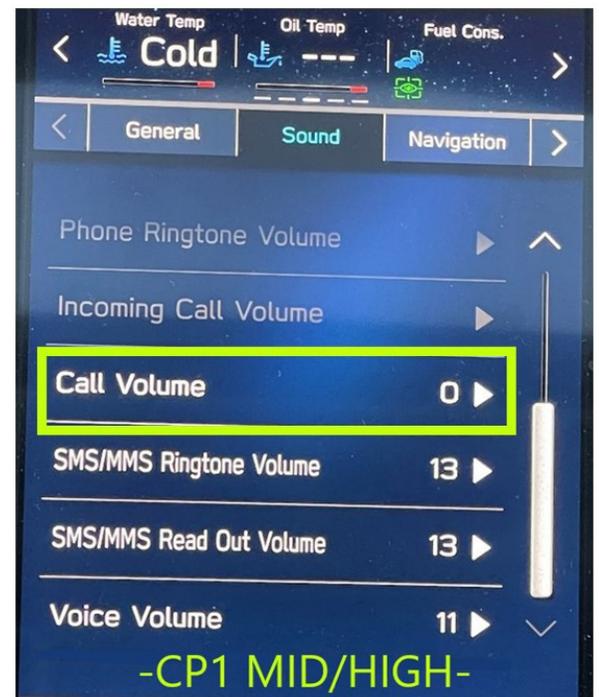
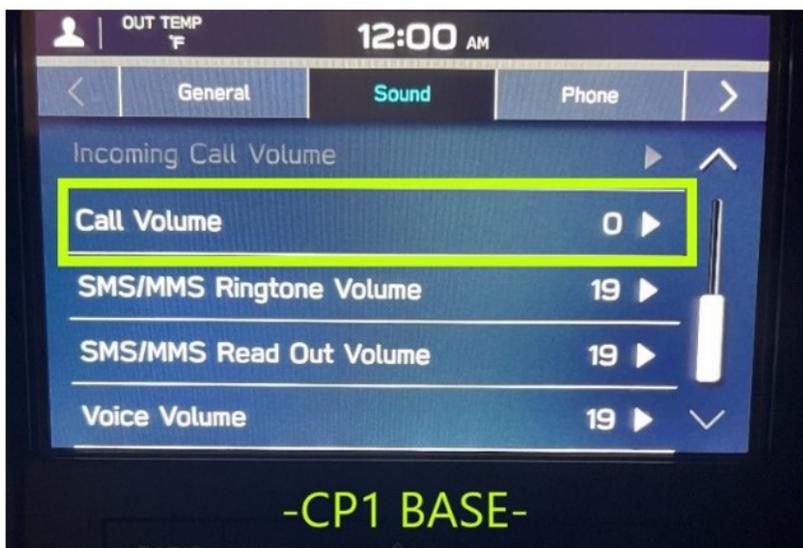
On Denso CP1 models, if the setting **Call Volume** is set to more than +/-2, the same condition can occur. Techline usually finds that the **Call Volume** has been turned up to +6 which creates the same conditions listed above. Some phones may require a +/- adjustment. However, Techline has not seen any models that need more than +1 to make the Bluetooth clear. Here is a picture of Base model CP1 and Mid/High CP1 for reference.

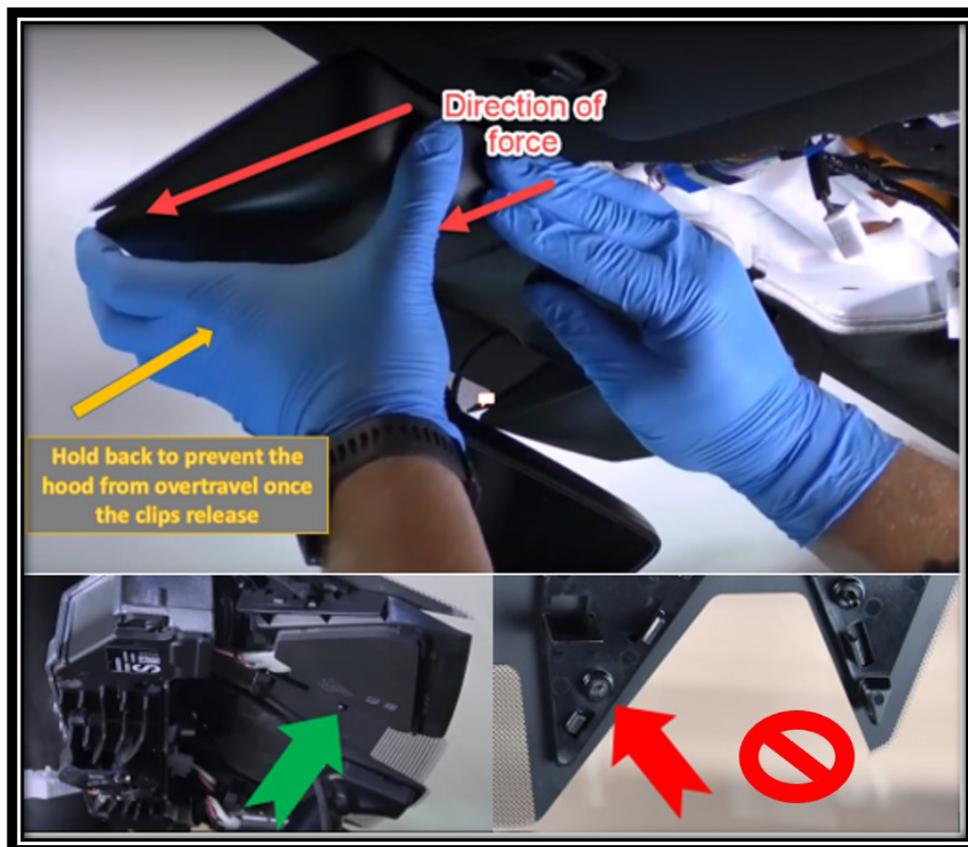
After removing the overhead console, the Eyesight cover is removed by applying pressure on the back of the cover to slide it forward. The technician should only try to release one side at a time. While applying moderate steady pressure to the back of the cover the technician should be applying pressure to the front of the cover to limit the travel when the tabs release. If the cover is not secured while being released, locating pins on the camera bracket may be damaged. Once the cover has been released from the clip on one side, the technician should perform the same procedure on the other side. The picture below shows the direction that the cover is removed. The lower section of the image shows the position of the heater locating pin. The lower right image shows where the improper removal of a cover resulted in the pin being broken off. Damage to the bracket or pin(s) can only be repaired through windshield replacement.

Generation 4 eyesight cameras have a new procedure for removal and installation. It is important to take care when removing and installing components as improper removal and installation practices can damage camera or windshield. The Eyesight cover, heater elements, and camera on the generation 4 system has been designed to snap onto a camera bracket that is bonded to the windshield. If the bracket is damaged the entire windshield must be replaced. The components have been engineered to be removed by hand. Do not use impact tools when servicing the eyesight camera components.

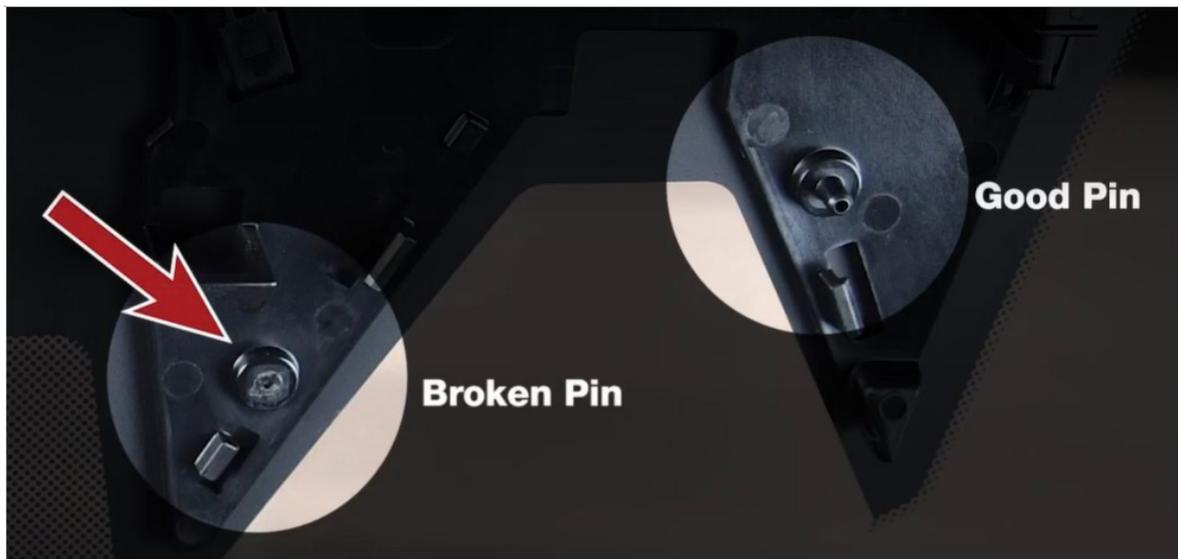
The camera has 3 mounting pins that engage the windshield bracket. A forward-facing locating pin is located centrally on the front of the camera and there two pins in the rear of the camera. The camera is removed by applying steady pressure in a rearward motion until the tabs are released. Only attempt to release one tab at a time or damage to the bracket may occur. When reinstalling the camera, the use the center pin to locate the camera. Then seat the camera on the bracket using one of the rear pins. Apply steady pressure to each pin. There will be an audible click when each clip is seated. Attempting to secure every pin at the same time can result in damage to the windshield bracket. Any damage to the bracket will require the windshield to be replaced.
