SERVICE INFORMATION BULLETIN

APPLICABILITY: 2012-16MY Impreza
2012-17MY Crosstrek
2014-18MY Forester

NUMBER: 18-219-22

SUBJECT: Service Manual Correction / DTC C2521
Electric Power Steering (EPS) Motor Malfunction
and/or DTC 21 Motor Failure 1 (Motor)

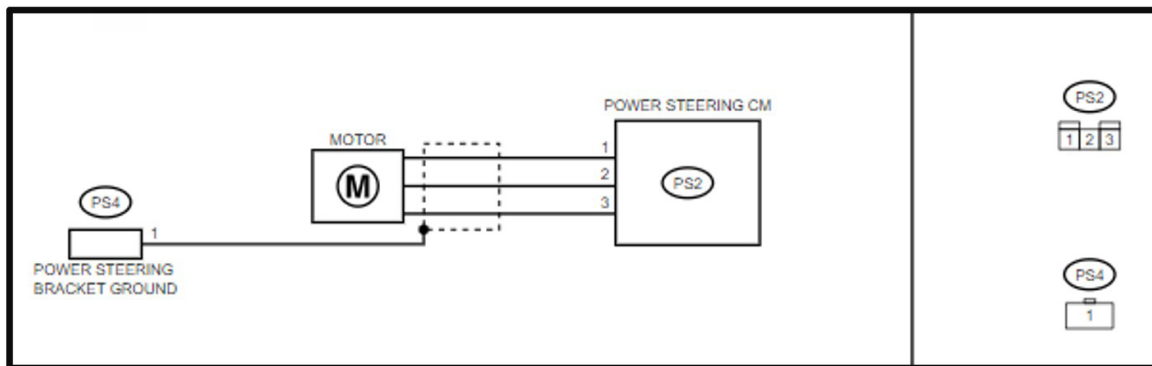
DTC C2521 MOTOR MALFUNCTION

STEP A: Checking Connection of the Motor Harness Connector

1. Turn the ignition ON.
2. Disconnect the PS2 connector from the power steering control module.
3. Check the condition of three terminal pins on the motor harness side of the PS2 connector.

Are there any of three terminal pins on the motor harness side of the PS2 connector loose or unsecured?

Yes Replace Power Steering Gear Box.

No Proceed to **STEP B**.
