FIELD SERVICE CAMPAIGN – 22109

10 May 2022

International® HV™ Transfer Case Cooler Line Routing

International® HV™ Series Trucks

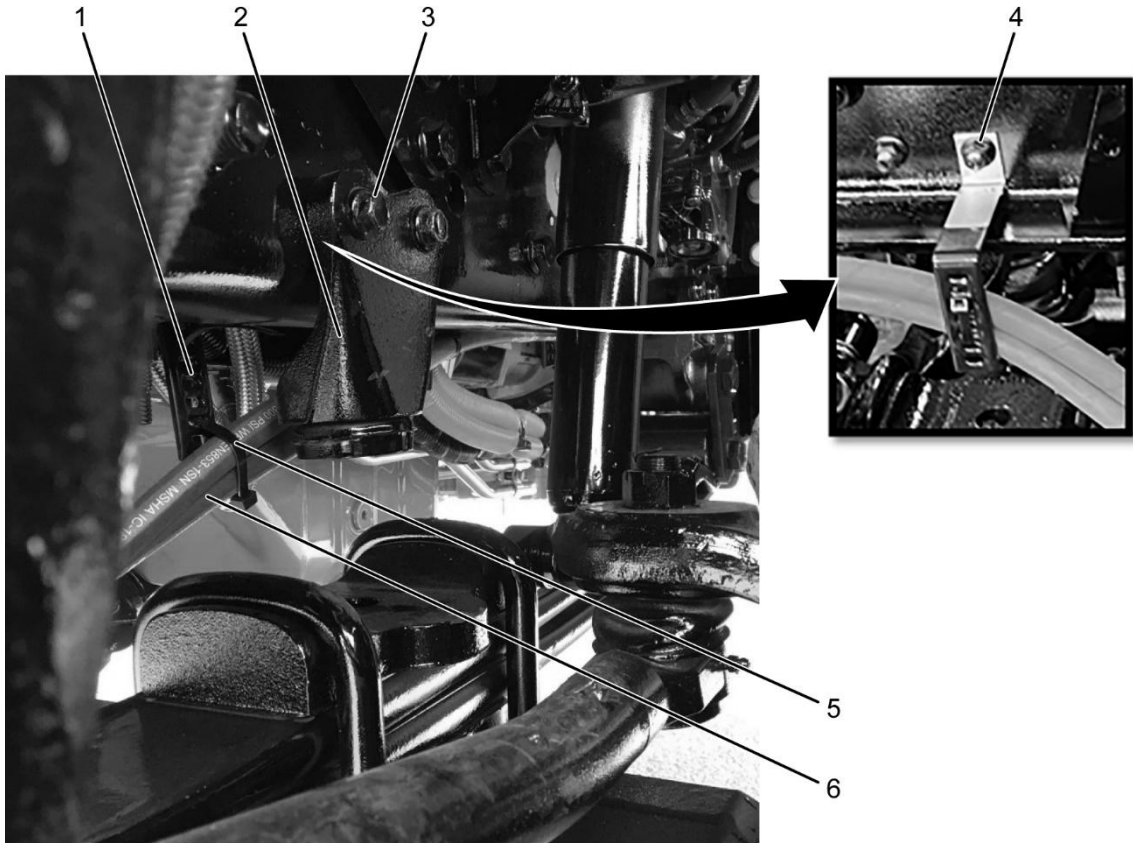
Figure 1. Front Suspension Bump Stop

Certain International® HV™ Series trucks may have transfer case cooler lines routed incorrectly that could result in chafing to the lines.

1. Body extension clip
2. Bump stop
3. Front bump stop M12 x 60mm bolt
4. Front bump stop M12 x 60mm nut
5. Cable tie strap
6. Transfer case cooler line (2)

5. Access front suspension bump stop (Figure 1, Item 2) located on driver-side.
6. Remove ONLY front bump stop M12 x 60mm nut (Figure 1, Item 4). Save nut for reuse.
7. Install body extension clip to front bump stop bolt and secure using previously removed M12 x 60mm nut.
8. Tighten front bump stop nut and bolt to 72 lb-ft (98 N•m).

9. Using cable tie strap, secure transfer case cooler lines (Figure 1, Item 5).
10. Remove wheel chocks.
