Mazda North American Operations Irvine, CA 92618-2922

DOOR OUTER HANDLE TOUCH SENSOR DOES NOT WORK (LOCK AND/OR UNLOCK)

Bulletin No.: 09-019/22

2019-2021 Mazda3 2020-2021 CX-30

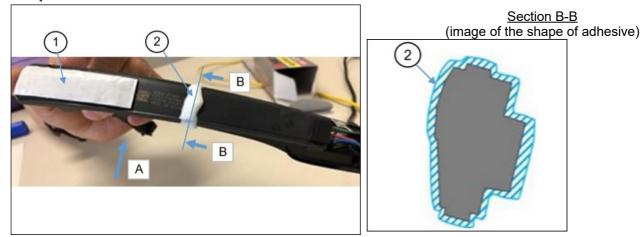
# View A

(1) Butyl tape

(2) Adhesive: Apply the adhesive around the touch sensor

4. Waterproof the outer handle and the touch sensor by applying adhesive to the touch sensor.

**NOTE:** White adhesive and a transparent touch-cover are used in the picture below to show the shape of adhesive clearly.

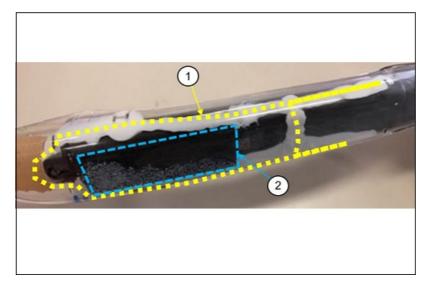
(1) Image of the adhesive application location(2) Butyl tape

8. Fill the adhesive from the back of the outer cover.

9. Let the adhesive dry for 2 hours, keeping the position of the outer cover so that the adhesive on the back of it does not drip.
