**Countries:** CANADA, UNITED STATES **Document ID:** IK0500063  
**Availability:** ISIS, FleetISIS, Body Builder, IsSIR **Revision:** 2  
**Major System:** STEERING SYSTEM **Created:** 2/22/2021  
**Current Language:** English **Last Modified:** 5/10/2022  
**Other Languages:** NONE **Author:** David Horner  
**Viewed:** 631

**Title:** CV 4x4 Undesirable Turning Radius

**Applies To:** Feature Code: 0005PSS- STEERING GEAR {Bosch S2 8014 Plus} Power with 0001ANB AXLE CONFIGURATION {Navistar} 4x4 Built Before 3/21/22

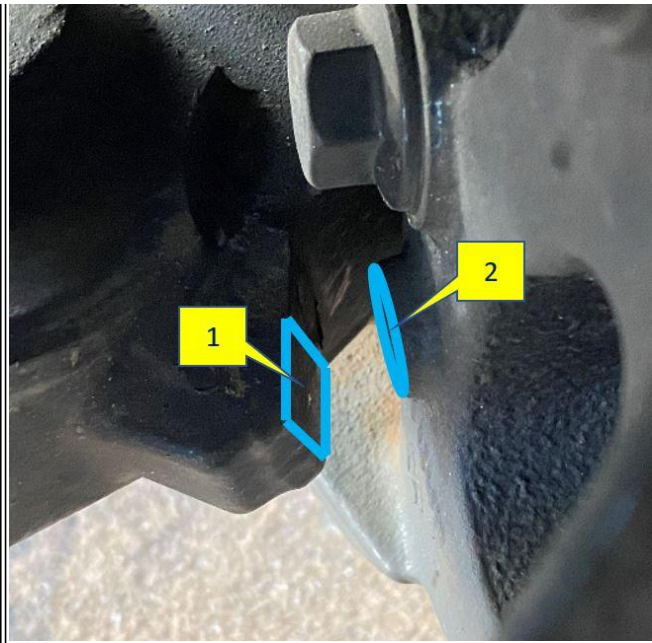
**Figure 1: Steering Arm & Axle Stop**

Item 1: Steering Arm  
Item 2: Axle Stop

14. Steer the wheels to the full left and right positions
15. Measure the distance from the spindle to the steering stop (Figure 1), if 0.125" +/- 0.025" go to step 20
16. If the spindle is making contact to the steering stop, center the steering wheel and shut off the engine
17. Remove and replace both steering gear poppets (Figure 2) with 6042264C1- SCREW, BOSCH AUTOMATIC RELIEF POPPET, 42.6MM and torque to 10ft-lbs

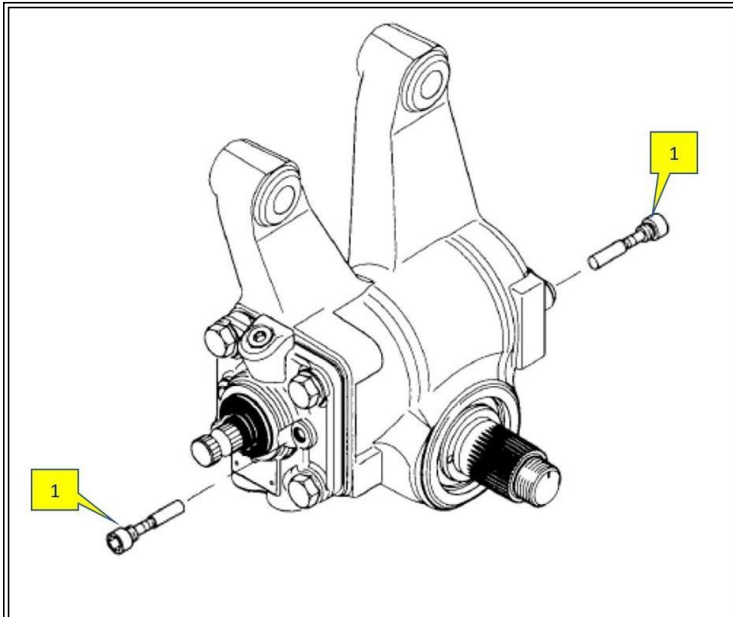
**Figure 2: Steering Gear Poppet Location**

Navistar has identified a condition where some 4x4 vehicle operators may report a symptom of undesirable steering turning radius. This condition may exist when the poppets, also known as steering limiting screws, located in the steering gear assembly are initially misadjusted. This initial mis adjustment allows the steering gear to begin relieving internal pressure much before the design intent relief position. This article will provide diagnostic steps to determine if the condition is present and when present; the repair steps to resolve without using turn plates

Item 1: Poppets / Limiting Screws

**NOTE: If the 42.6mm relief poppets are not available using Navistar parts catalog, replace the steering gear**
