SS 3102 FTL-2022 P4 with 100/120/130 Gallons Fuel Tanks interference/rubbing with fairing bracket.

Applies to all New Cascadia (P4) vehicles built with 100/120/130 Gallons Fuel Tanks.

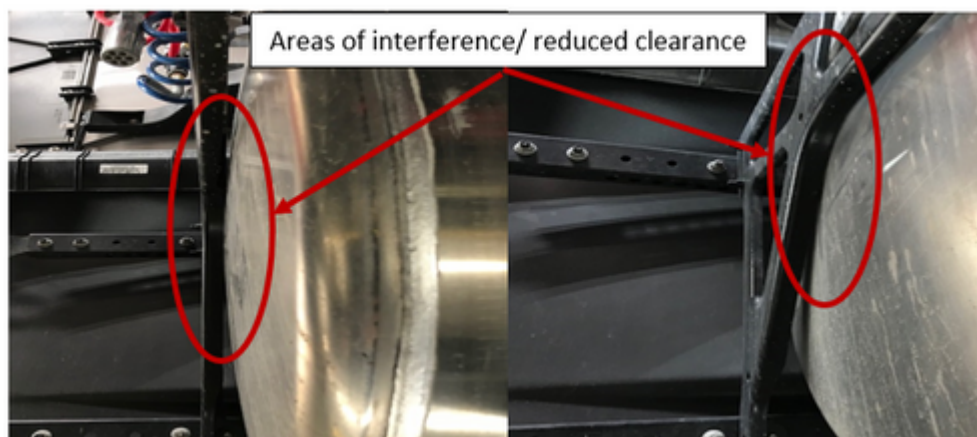
Fuel Tank installation may have reduced clearance with Fairing Brackets (LHS), mainly due to tolerance stacking. This reduced clearance causes interference/rubbing issues of Fuel Tanks with Fairing Brackets at low mileages that may cause Fuel leaks and require Fuel Tank replacement.

Figure 1: Fuel Tank - Fairing Bracket Interference/Rubbing issues.

The Fairing Bracket installation needs to be modified to increase the clearance/eliminate the interference with the Fuel Tank in the LHS Fairing Bracket installation. Follow the next steps to increase clearance/eliminate interference:

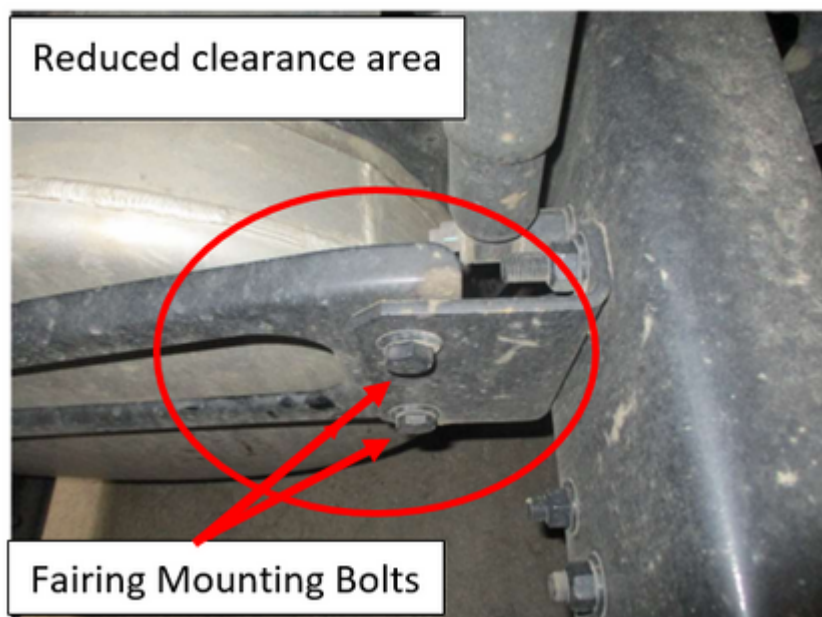
Figure 2: Reduced clearance at the Fairing Frame mounting Bracket area.

a) To increase clearance at the Frame mounted Fairing Bracket area shown in Figure2:

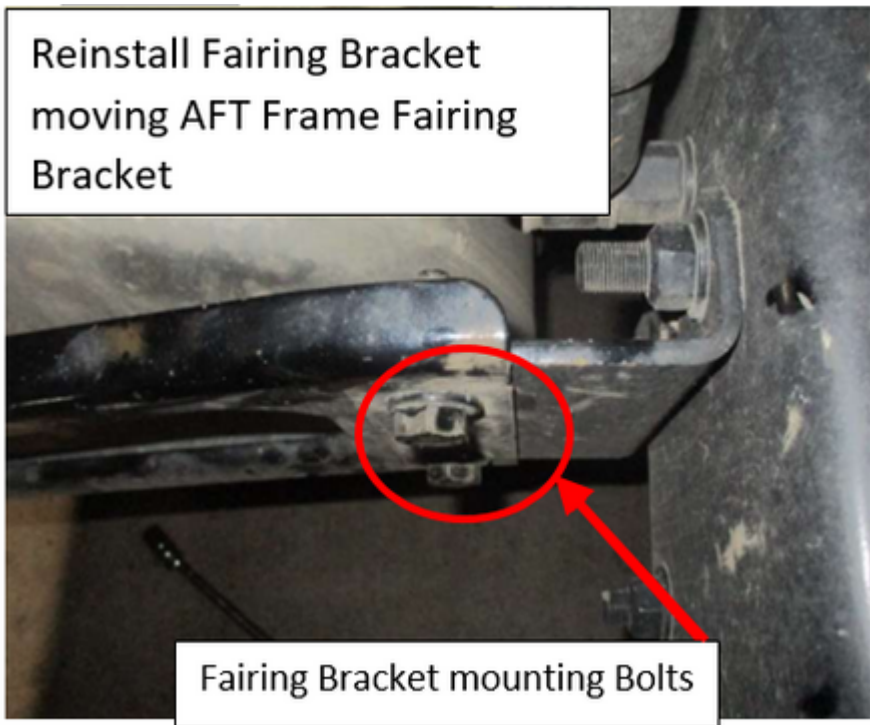
Figure 3: Fairing Bracket moved AFT the Fairing Frame Bracket.

i. Remove Fairing Bracket mounting bolts and install Fairing Bracket as shown in Figure 3.

ii. Reinstall Fairing Bracket as shown in Figure 3 and torque mounting bolts to $235 (+/- 24) \text{N*m}$ ($174 (+/- 18) \text{Lbf*Ft}$).

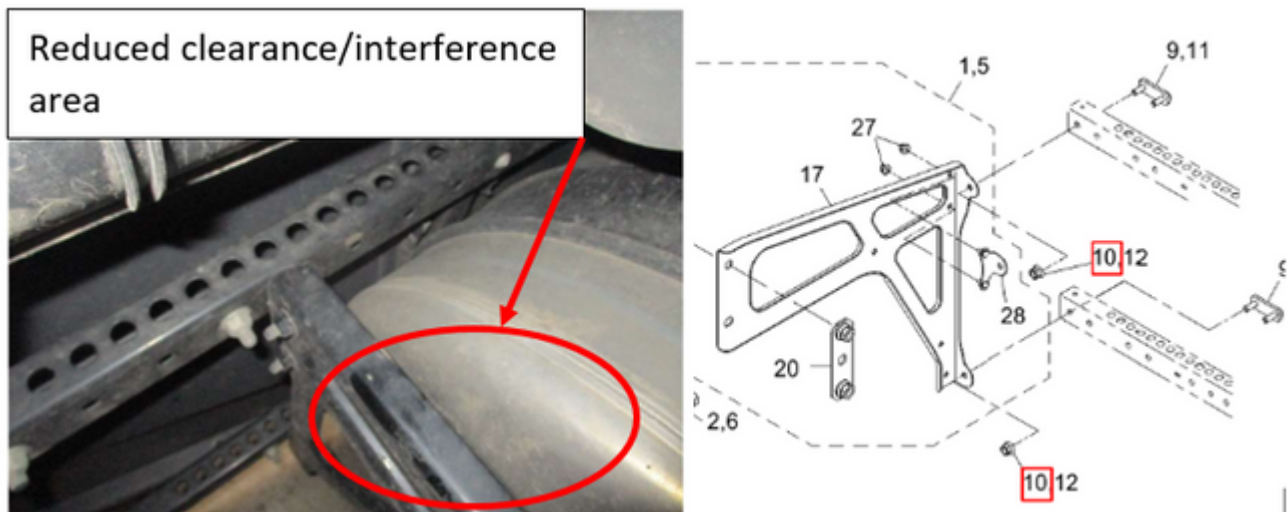
Figure 4. Reduced Clearance/Interference at the Fairing Rail Bracket mounting area.

b) To increase clearance/interference at the Fairing Rail Bracket area, shown in Figure 4:

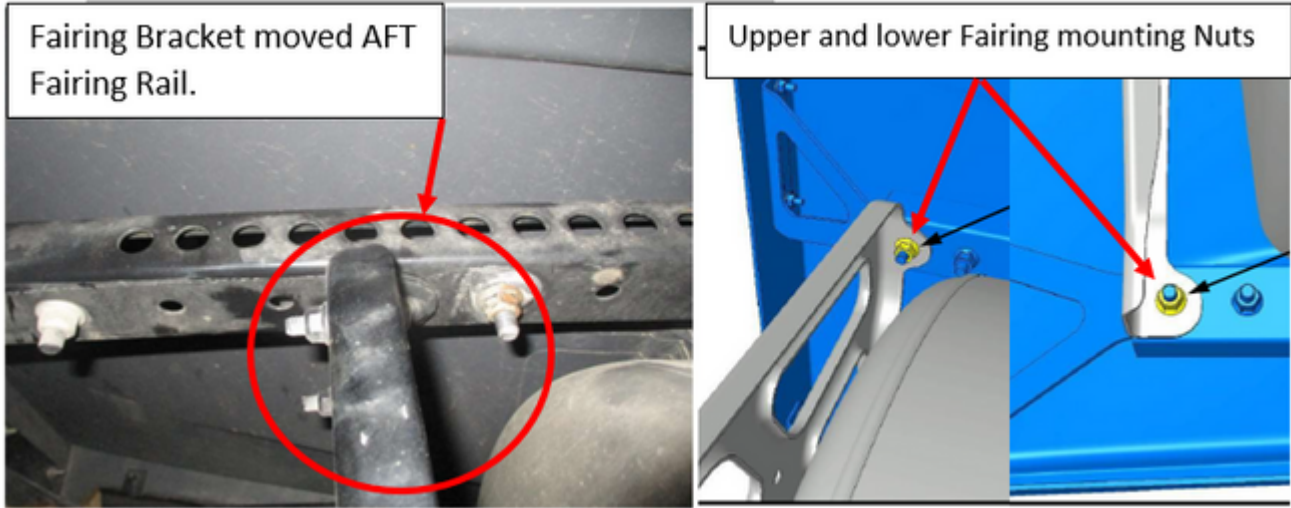
Figure 5: Relocation of Fairing Bracket AFT in Fairing Rail.

i. Remove Item 10 lower and upper mounting Nuts, and position the Fairing Bracket AFT in the Fairing Rail as shown in Figure 5. Reinstall Nuts, torque Nuts to 47 (+/- 5) N*m (35 (+/-4) Lb*Ft) and proceed to next step.

ii. Remove upper and lower Nuts Item10 from Fairing Rail and reinstall Fairing Bracket in its new position as shown in Figure 5, torque Nuts to 47 (+/- 5) N*m (35 (+/-4) Lb*Ft).

iii. Verify clearance between Fairing Bracket and Fuel Tank has been increased at both sides of the Fairing Bracket mounting.
