Steering column cover, squeaking noise

REF NO: TJ 35892.2.0	ISSUING DEPARTMENT: Technical Service	CAR MARKET: United States and Canada	
PARTNER: 3 US 7510 Volvo Car USA		ISSUE DATE: 2022-02-04	STATUS DATE: 2022-02-09
FUNC GROUP: 6415	FUNC DESC: STEER WHEEL, COLUMN, COLUMN LOCK, SHAFT	Page 1 of 11

TJ Instruction VCC-520658-1

Title	Panel steering column	Page	1 (9)
Action	Product fix	Operation number:	98762-2

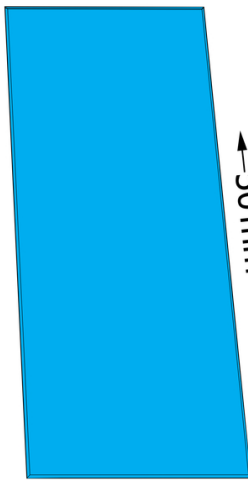
←20 mm→

Use: Anti-squeak tape , 1161842

x2
