2022 Ontour

ONTOUR 2.2 SQUEEK NOISE FROM MIDDLE KITCHEN GALLEY

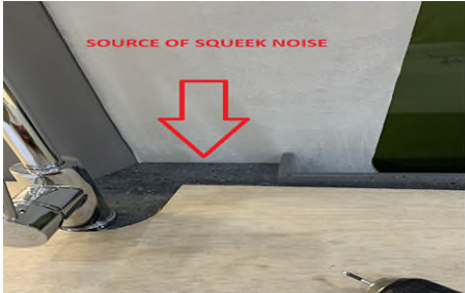
CUSTOMER INDICATED THE SQUEEK NOISE WAS COMING FROM WHERE THE COUNTER TOP MEETS THE FELT WALLS BEHIND THE KITCHEN GALLEY.
