# RYKER 2022 Possible Steering Column Threads Issue - 140065

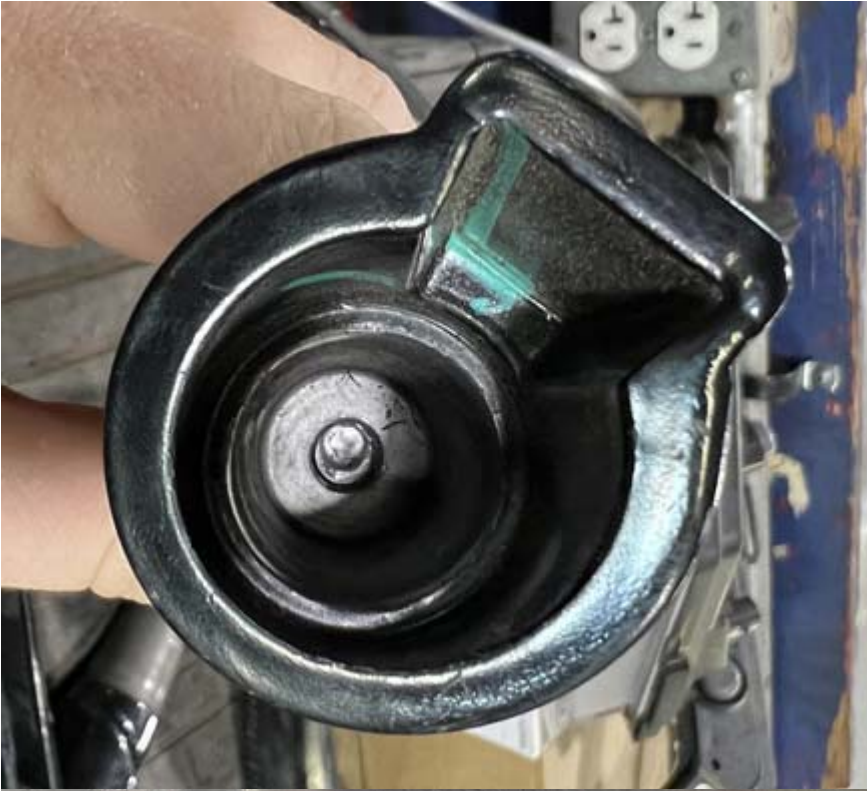
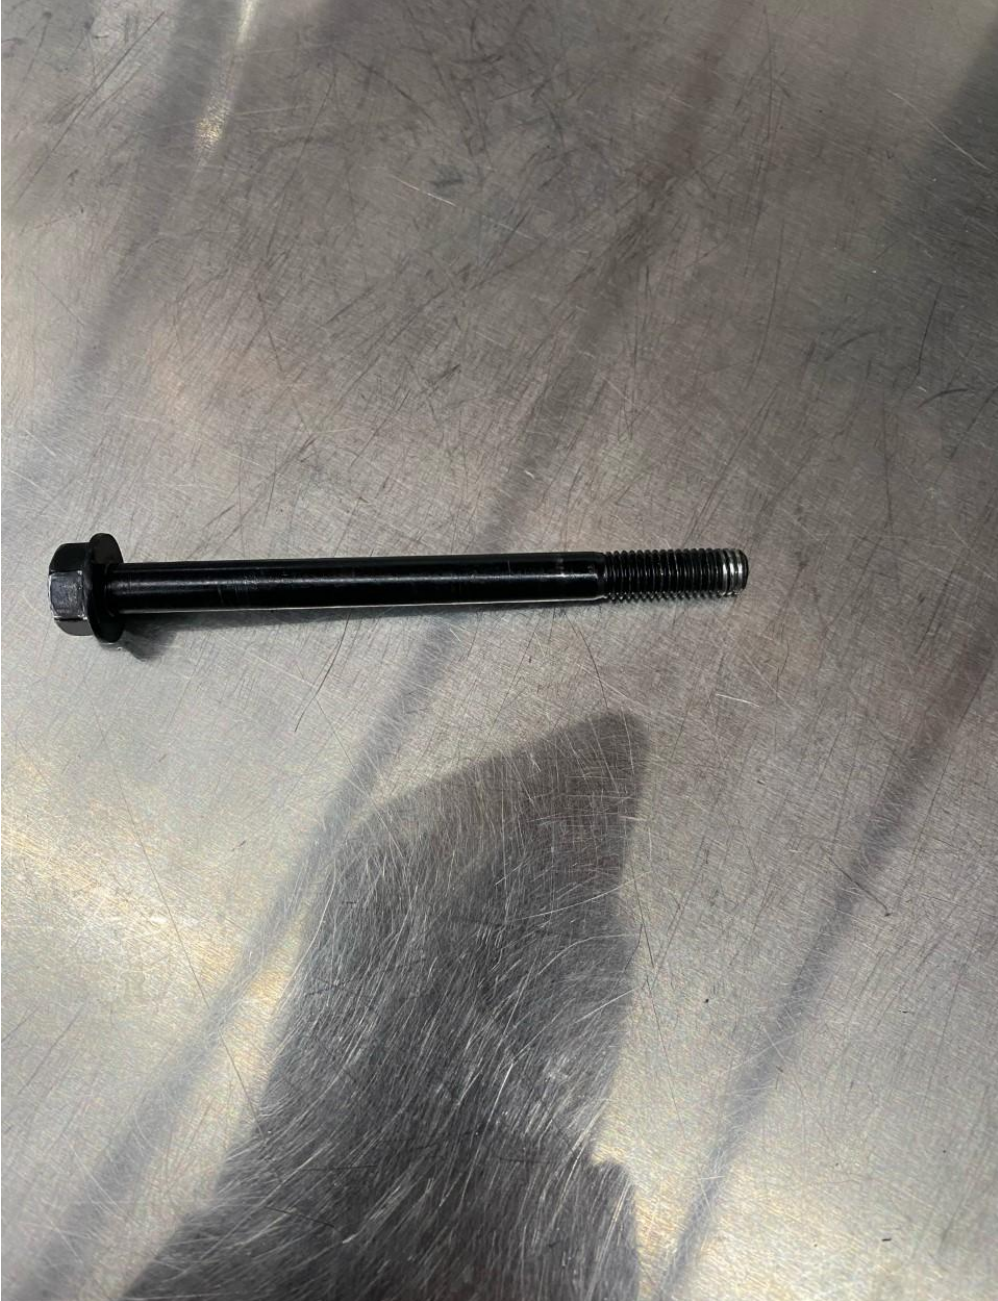
We actually received some reports mentioning that the handlebar is not well fixed and turns in its taper once installed at PDI. Two different causes are reported.

- The bolt that breaks before reaching the prescribed torque
- Damaged bolt threads after installation

So far the thing that seems to work well for most cases I've looked at is to use a thread chaser and re-do the steering column threads before installing the steering stem to the steering column at the PDI. The thread size used is M8 x 1.25.
