## Spyder 2022 Horn Not Installed Properly - 140102

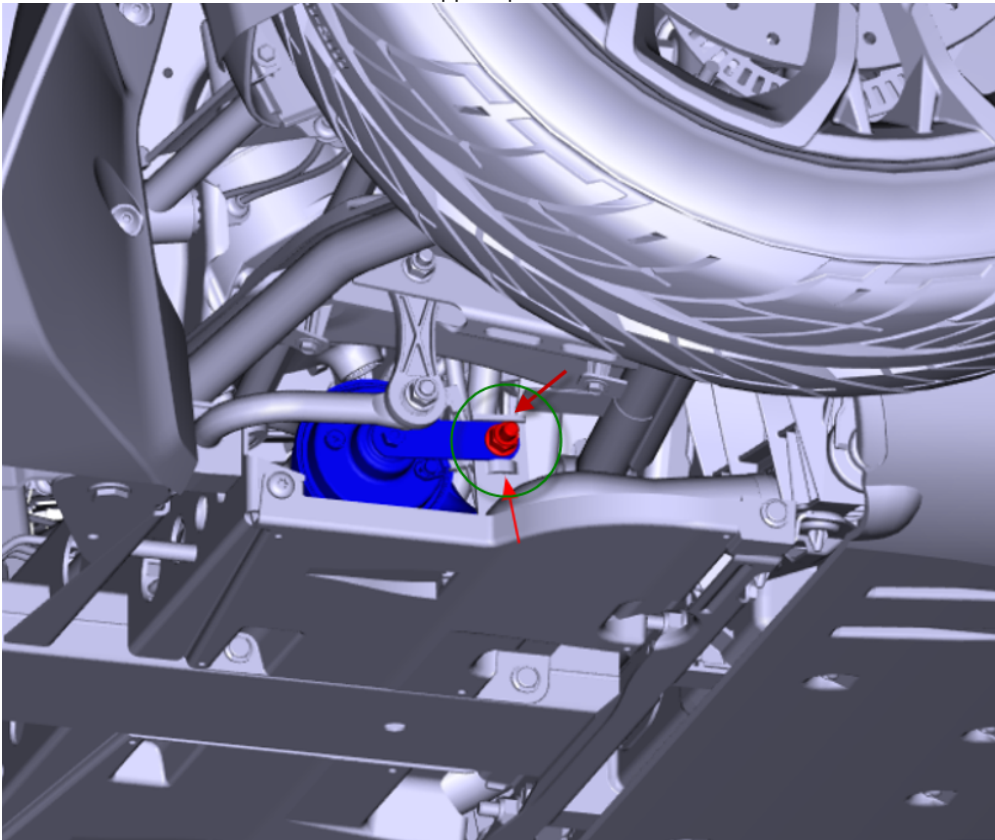
The horn arm has been installed on the other side of the bracket so it is not positioned between the 2 stoppers, which causes a loose horn that can come into contact with the tie rod.

Install the horn bracket between the 2 stoppers pointed with the red arrows

Check for proper bracket installation as shown in the above picture.
