# Service Update

## N212352670 Software Update For Multiple Modules

**Release Date:** June 2022

<b>Condition</b>	Certain 2022 model year CT5-V Blackwing vehicles may have modules that require software updates to improve performance.
<b>Correction</b>	Dealers will update the multiple modules with a software update.

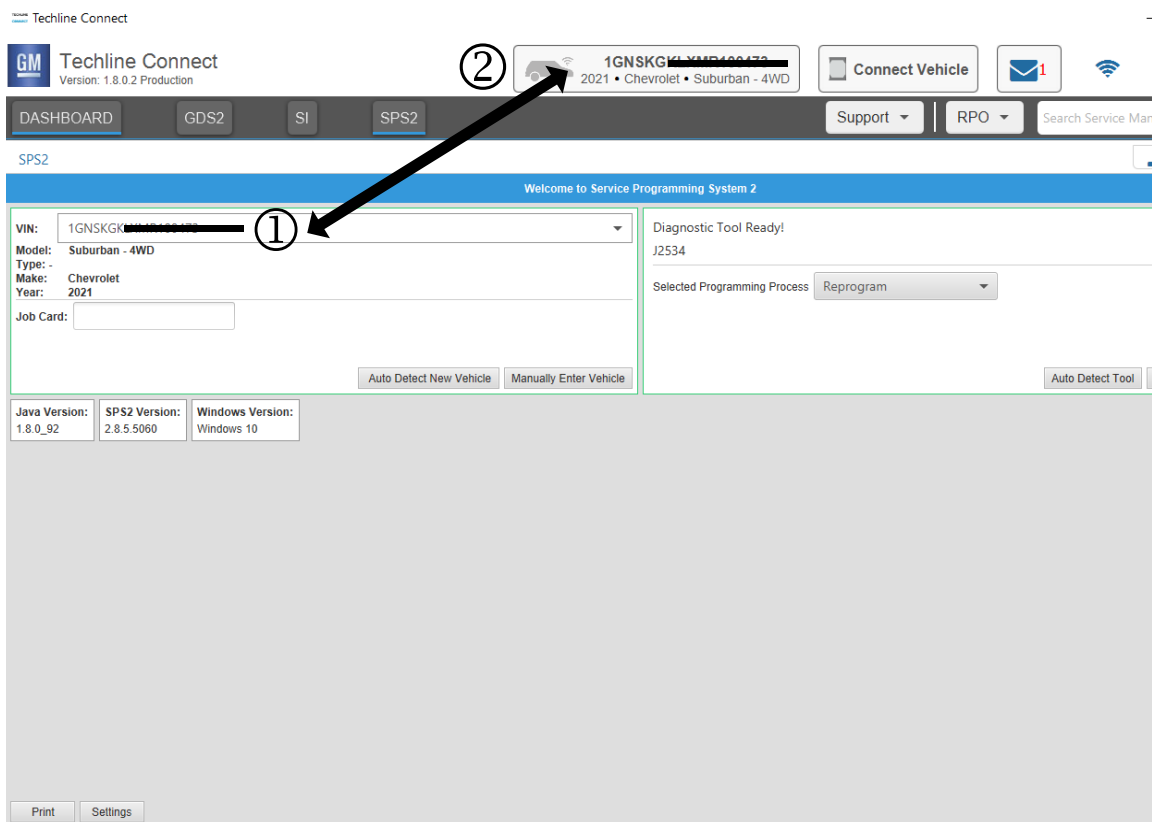
5743643

**Caution:** Be sure the VIN selected in the drop down menu (1) is the same as the vehicle connected (2) before beginning programming.

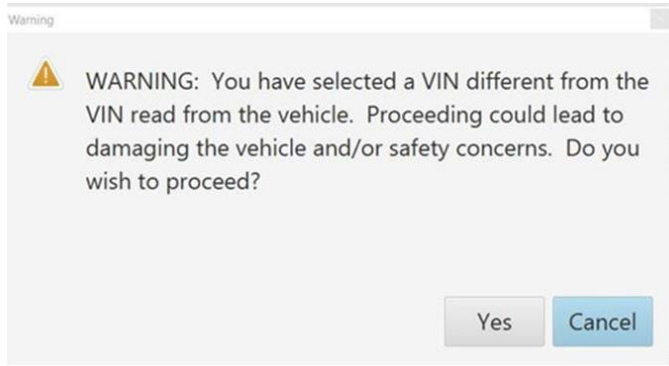
5877000

**Important:** If the vehicle VIN DOES NOT match, the message below will be shown.

**Important:** If the same calibration/software warning is noted on the TLC Summary screen, select OK and follow screen instructions. After a successful programming event, the WCC is located in the Service Programming System dialogue box of the SPS Summary screen. No further action is required. Refer to the Warranty section of the bulletin.

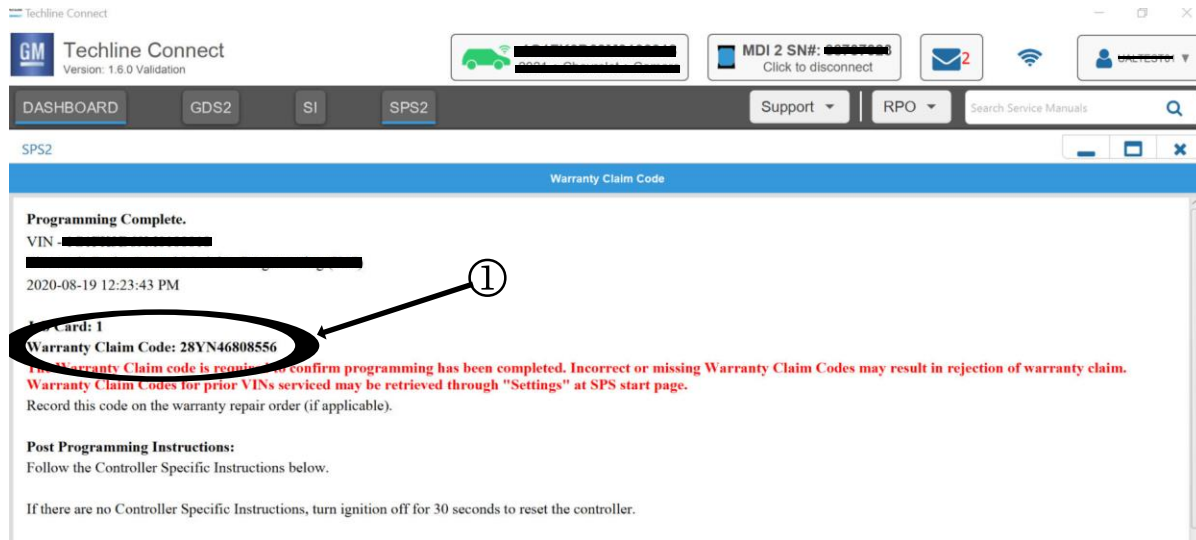
5644478

**Note:** The screenshot above is an example of module programming and may not be indicative of the specific module that is being programmed. Module selection and VIN information have been blacked out.

**Important:** To avoid warranty transaction rejections, you **MUST** record the warranty claim code provided on the Warranty Claim Code (WCC) screen shown above on the job card. Refer to callout 1 above for the location of the WCC on the screen.

- Record SPS Warranty Claim Code on job card for warranty transaction submission.
