Service Bulletin

Bulletin No.: 18-NA-069

Subject: Poor Engine Performance in Extremely Cold Weather Conditions for LFV Engines, Charge Air Cooler Icing - Malfunction Indicator Lamp (MIL) Illuminated - DTC P0299, P0234, P2227 and/or P00C7 Set

Brand:	Model:	Model Year:		VIN:		Engine:	Transmission:
		from	to	from	to		
Chevrolet	Malibu	2016	2022	—	—	1.5L (LFV)	—

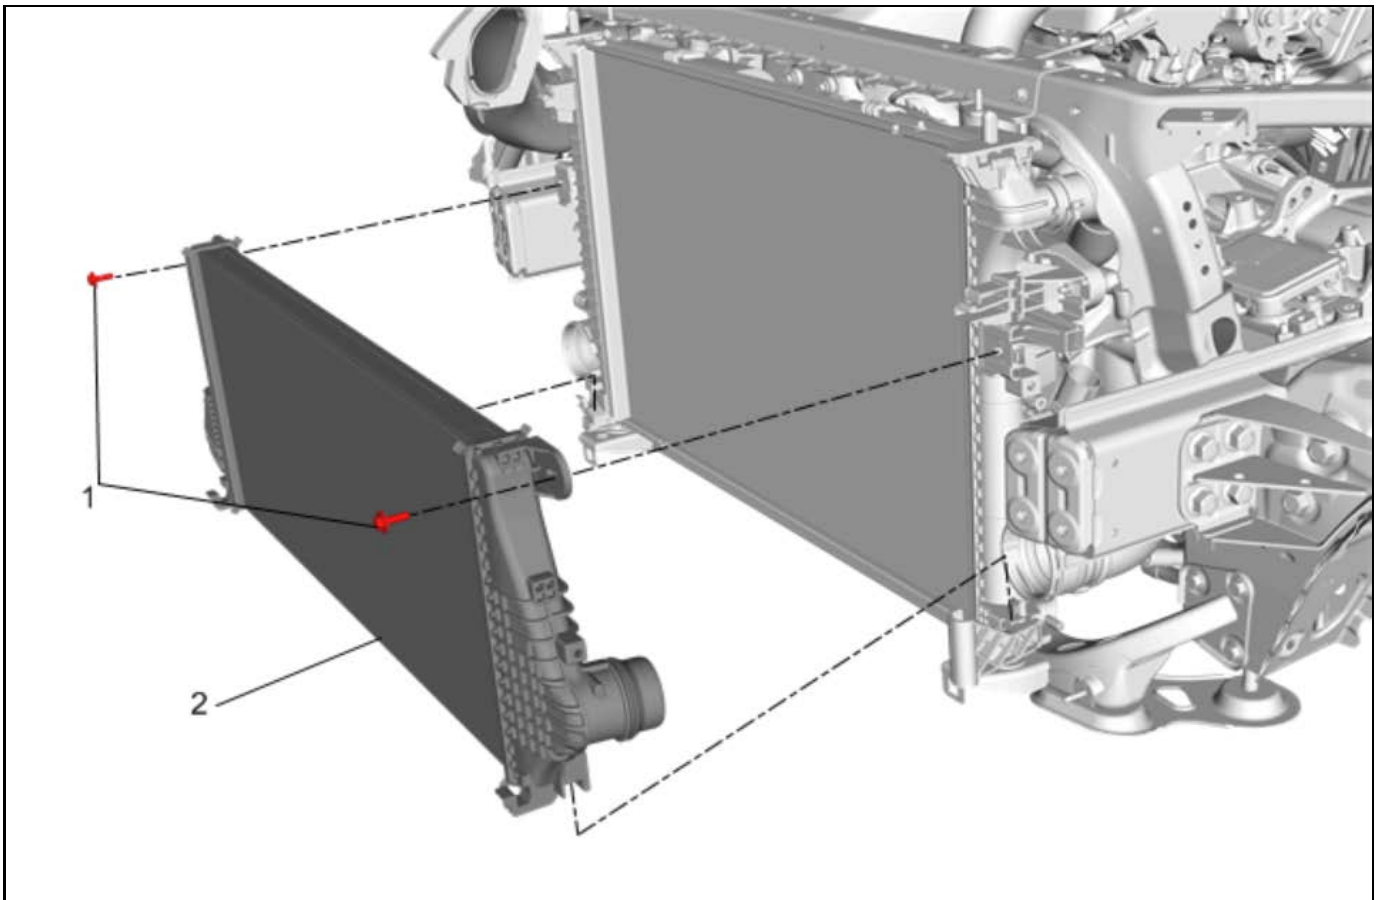
4241877

Important: Do Not replace the CAC ducts as part of this repair unless there is evidence of damage and/or a leak from the CAC ducts.

1. Install the CAC (2). Refer to *Charge Air Cooler Replacement* in SI.

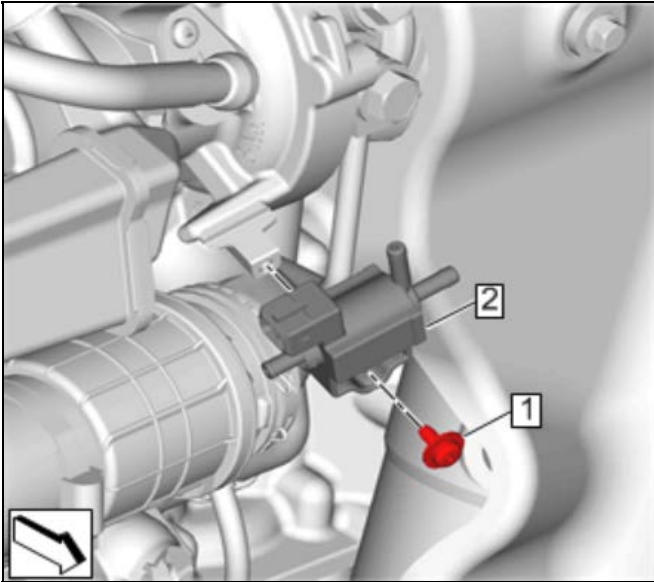
4823346

Note: Check port #2 to assure the spring gets lifted off the seat. This will be determined by the compressed air not dead heading when applied to port #2. When applying air to this port, a small amount of air should be observed at port #3 and even less air will be noticed at port #1. If this does not happen, the TCV plunger may have hardened deposits from hot operating conditions which will impede TCV plunger movement, and the TCV should be replaced.

2. Remove the turbocharger wastegate regulator solenoid valve (TCV) (2). Refer to *Turbocharger Wastegate Regulator Solenoid Valve Replacement* in SI.
3. Drain the TCV by turning the valve upside down.

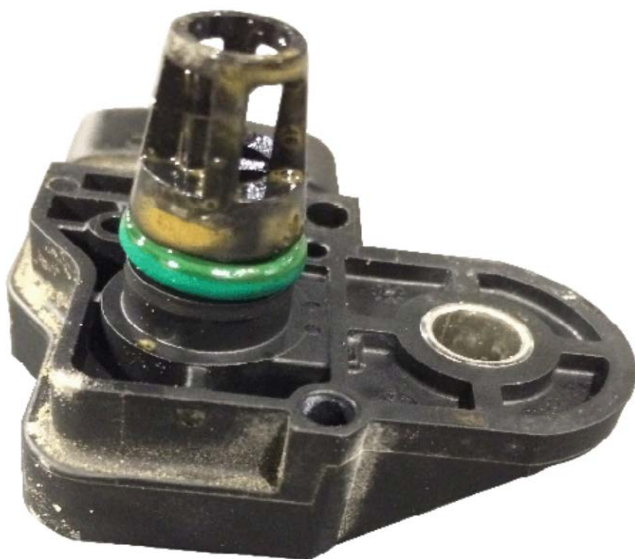
4910683

2. Inspect the sensor of any contaminates.

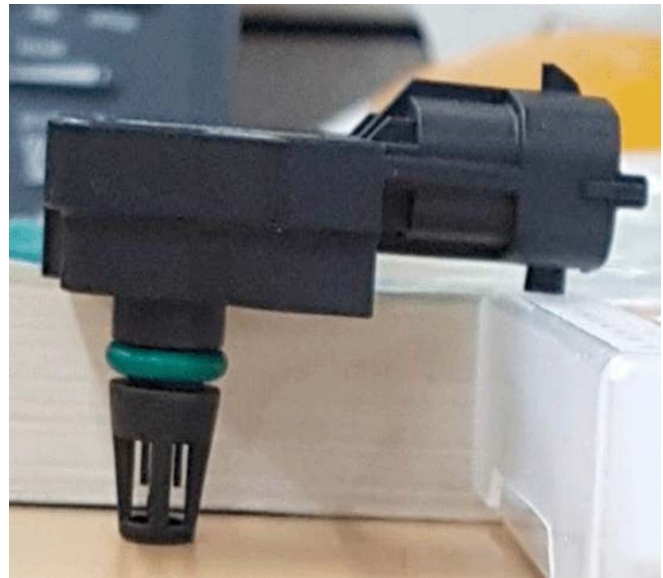
5020216

Important: Due to the sensitivity of the sensor, **Do Not** use any chemical cleaners including water and **Do Not** use compressed air to remove contaminates.

3. Allow time for any ice build-up to melt by placing the sensor port down.
4. Clean the sensor with a clean towel.
5. Install the sensor.
