Service Bulletin

Bulletin No.: 21-NA-230

Subject: Whining/Whirring, Whistle, Squeaking, Groaning/Growling Noise Coming from Front Wheel/Engine Area

Brand:	Model:	Model Year:		VIN:		Engine:	Transmission:
		from	to	from	to		
Cadillac	CT6	2016	2020	—	—	—	—

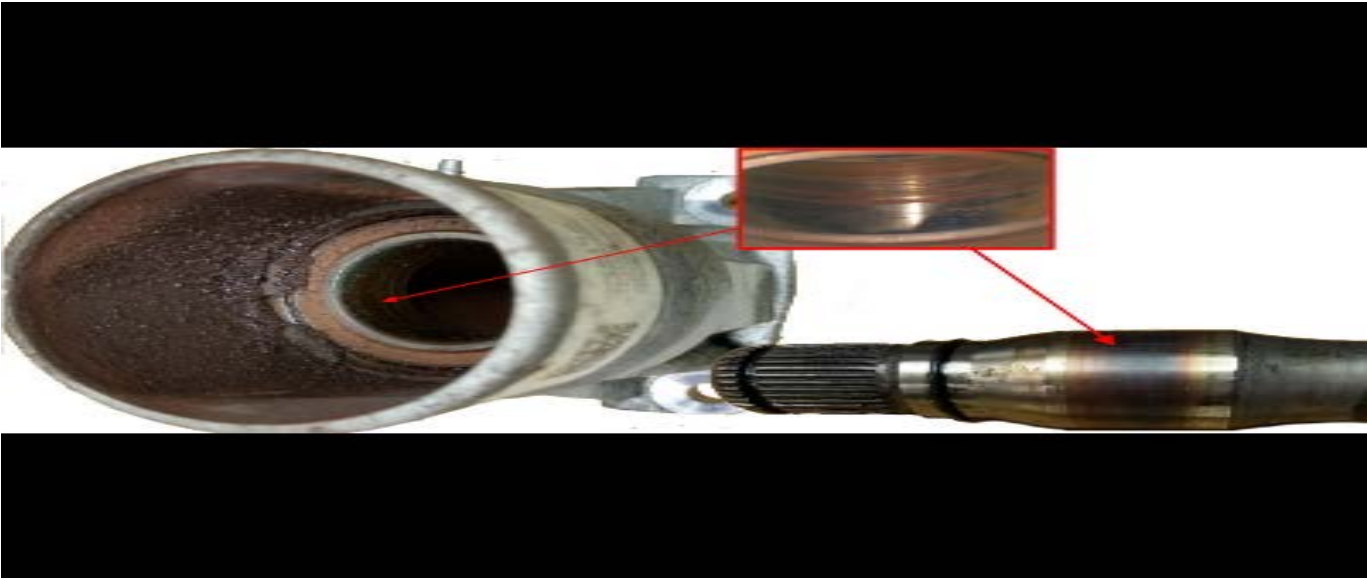
5875997

Note: Fretting worn IDS Shaft and Bracket must be discarded and replaced with new parts. Replace the housing only if damage has been verified.
